The Hoffman and Reynolds Houses

Historic Structure Report

PREPARED FOR
THE DYSON FOUNDATION
MILLBROOK, NEW YORK

FEBRUARY 2013

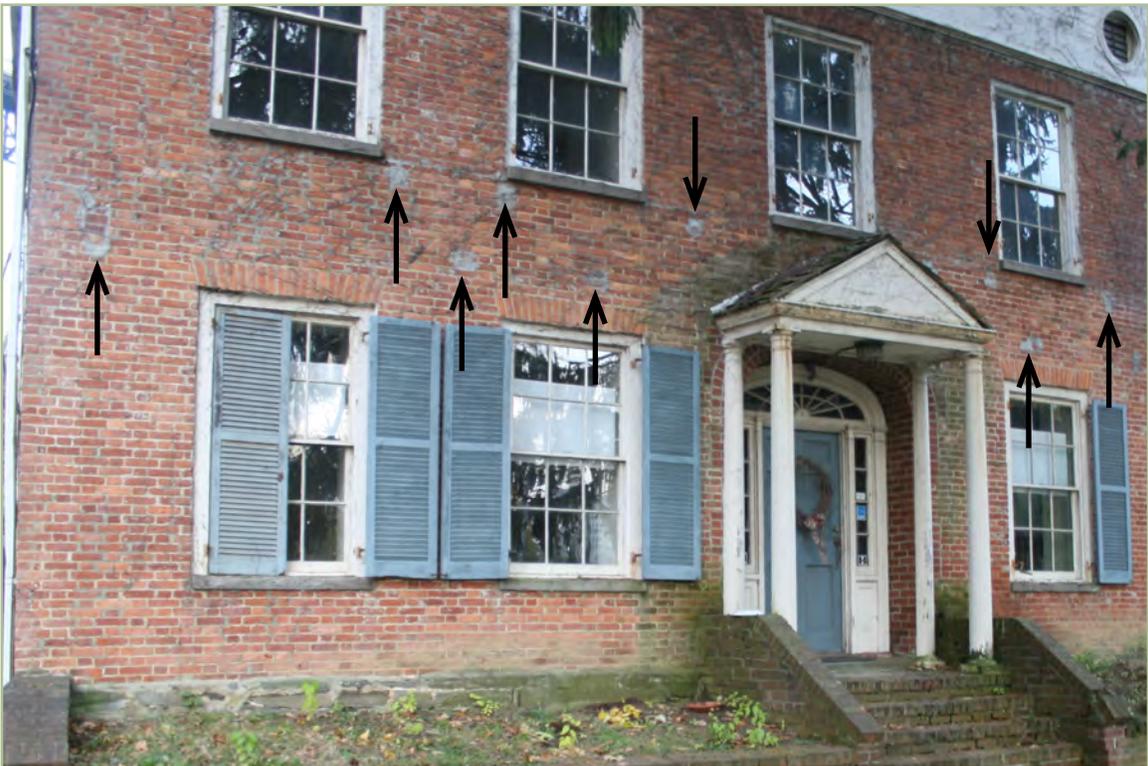
Fig. 22 - Hoffman house, south elevation. Areas of patched brickwork where framing for the porch roof was located.

The brickwork is in good condition. Locations of Portland cement patches exist in areas where framing for the porch roof was anchored to the building. Areas of the brickwork are soiled, especially adjacent to the roof of the portico. The scattered remains of creeping vines remain attached to the wall surface.

- All pointing and masonry repairs should be performed using lime mortar. Portland cement based mortar must not be used on this building. This material is incompatible with the historic masonry used in the construction of the house and must not be employed in repairs.
- Remove dead vegetation/vine from the sidewalls.
- Clean building with a mild detergent solution and low pressure water.

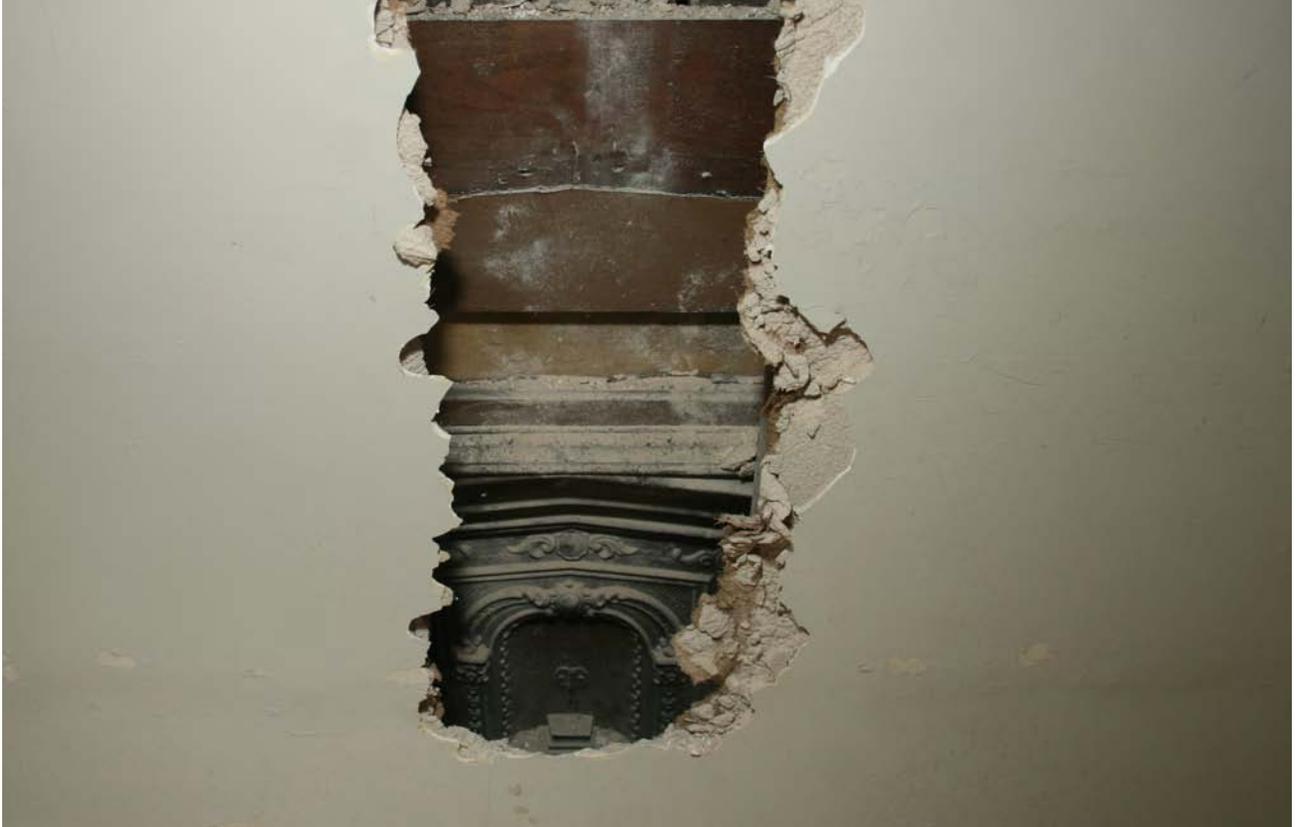
Fig. 30 - Hoffman house. First floor, southwest room. The fireplace opening here contains remnants of a mantel and cast iron insert.

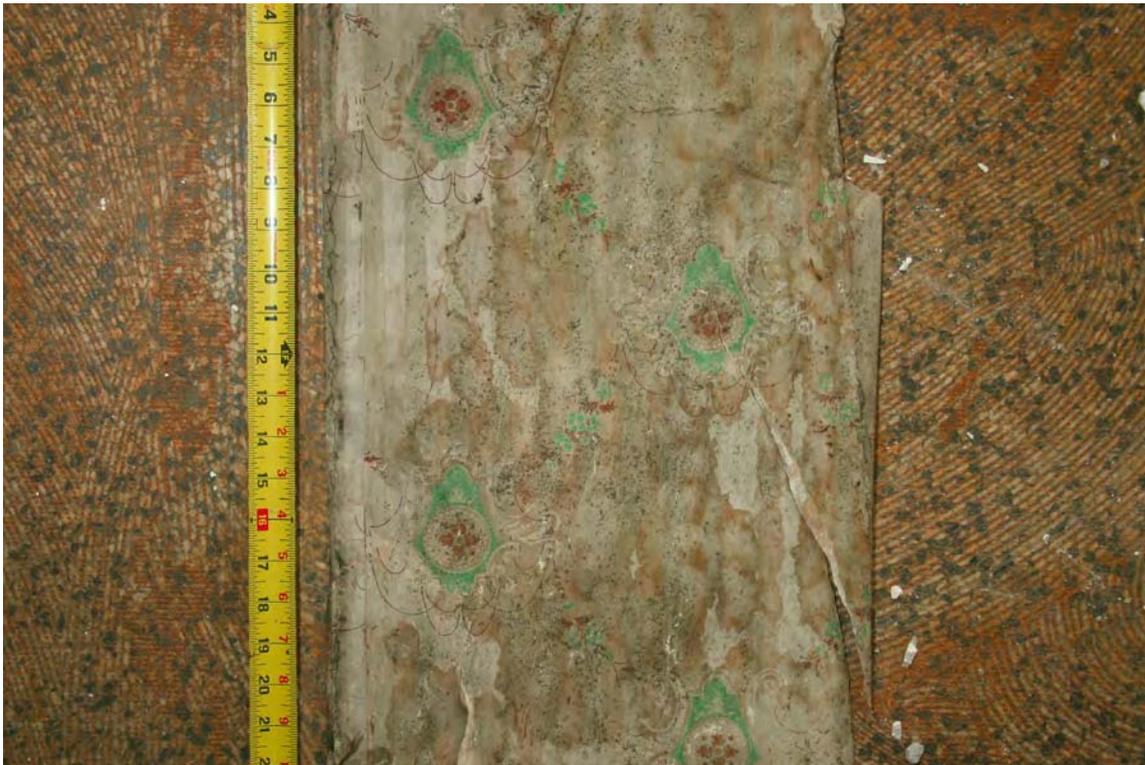
- Two generations of wallpaper on the south wall between the window openings (Fig. 33). The top layer of paper dates to c.1850-c.1870; the lower paper was in such poor condition its pattern was not discernible.
- The fireplace opening has remnants of a wood mantel and cast iron insert set within the fireplace opening (Fig. 30). Both of these elements appear to date to the last quarter of the nineteenth century.

Fig. 33 - Hoffman house. Wallpaper fragment found on wall of southwest room, first floor. Pattern dates to c.1850 - c.1870. Another paper was located under this one; however, it was in too poor of a condition to identify it.

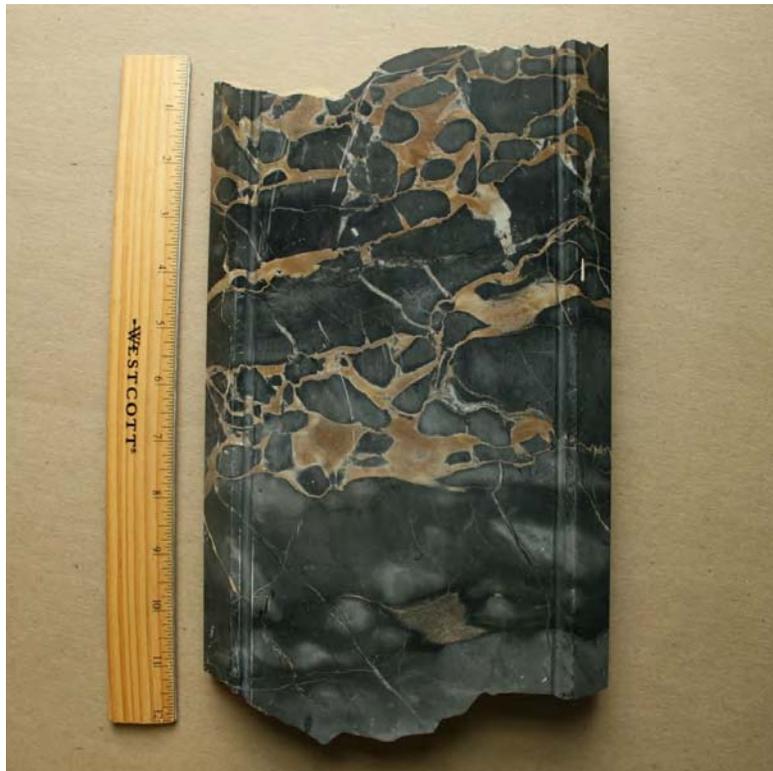
Fig. 34 - Fragment of the black marble mantel once located in the first floor, southeast parlor. Writing on a photograph showing one of the parlors notes that there were two black marble mantles in the house. Likely one in each of the two parlors.

- A fireplace is located in the east wall of the room. Fragments of a black marble mantel were found stacked inside the firebox (Fig. 34). The stone has the appearance of Portoro marble from the La Spezia region, Liguria, Italy. This marble was exported to England and France during the 18th, 19th, and 20th centuries and largely used architecturally and for furniture.¹
- Of the two pieces examined, one was a plinth block on which a pilaster would have stood, and the other was a portion of pilaster. The piece of pilaster measures 7" wide and has a one inch filleted chamfer along each edge.

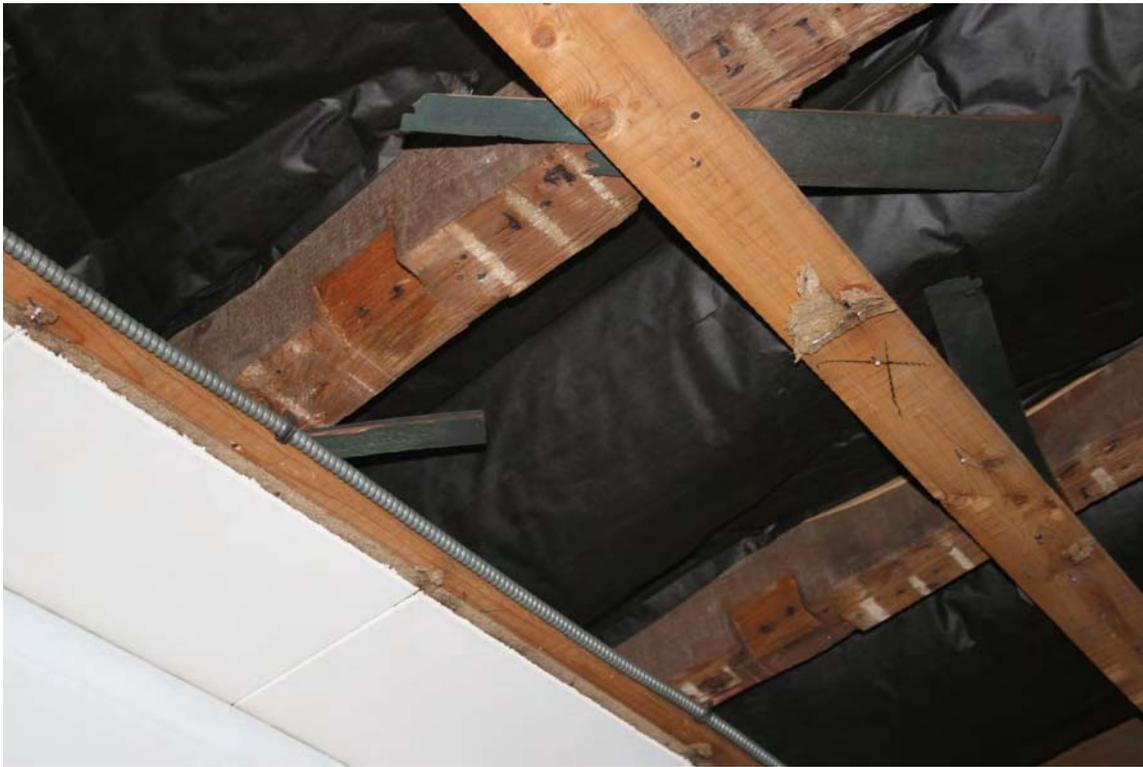
- This area would have contained the stair believed to have run between the two floors here.
- Bevel cut, half-lap joints in the ceiling joists here indicate where the walls partitioning this space were originally located (Fig. 37). These were located in two areas of the ceiling framing suggesting at least two sets of walls, one to the north and one to the south, defining the stair enclosure. A single, rose-head wrought nail was found embedded in the masonry where the south wall would have met the masonry.

Fig. 37 - Hoffman house. Second floor, west of stair hall, middle room. Bevel cut, lap joints indicate the locations of where earlier stud walls were located. This detail was used throughout the house to frame the walls.

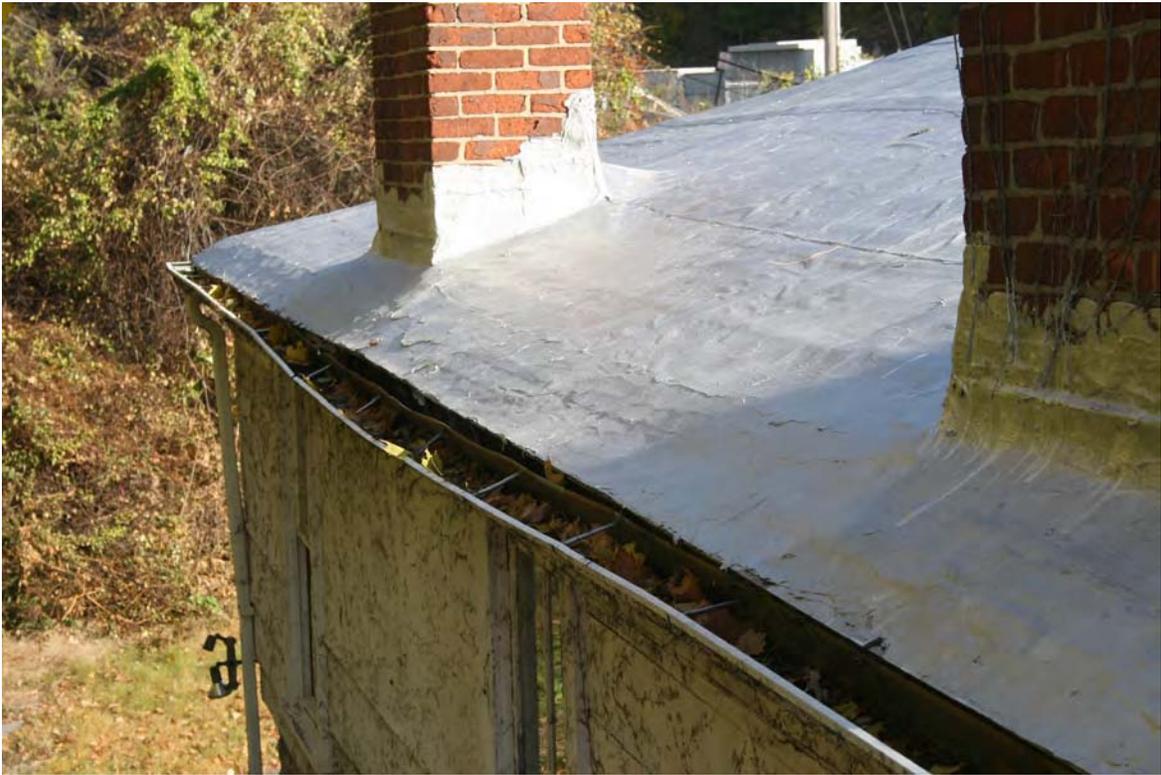
A low pitch, double hip roof with a near flat center area covers the building. The roofing material consists of a built-up roofing system that has been covered with a liquid applied coating. The age of these materials is not known; however, they likely represent two different campaigns with the coating applied to extend the service life of the built-up roof. Aluminum drip edges are installed at the edges and seamless aluminum gutters run around the perimeter of the building. The entire soffit around the perimeter of the roof has been rebuilt as well. This work is not particularly old; however, given its

Fig. 40 - Hoffman house. West side of roof. Representative example of coated, built-up roof, chimney flashings, and gutter system. Note damaged gutter filled with leaves, and remains of vines on wood siding.

poor condition it has existed for a few decades at least. The roof is penetrated by four chimney stacks, a scuttle and skylight, and two vent stacks. These penetrations have been heavily covered with the coating used on the roof in a makeshift effort to seal them from the weather. This appears to be working in spite of the crude and unsightly nature of the workmanship.

- Install New Roof - Owing to the age and condition of the existing roof, any treatment short of replacing the roof is essentially a temporary measure. The existing roof should be stripped down to the sheathing boards and replaced with a new roof. Considering the style and pitch of the roof, options for replacement vary and largely depend on budget and service life. Options include:
 - Flat seam lead-coated copper or Freedom Gray

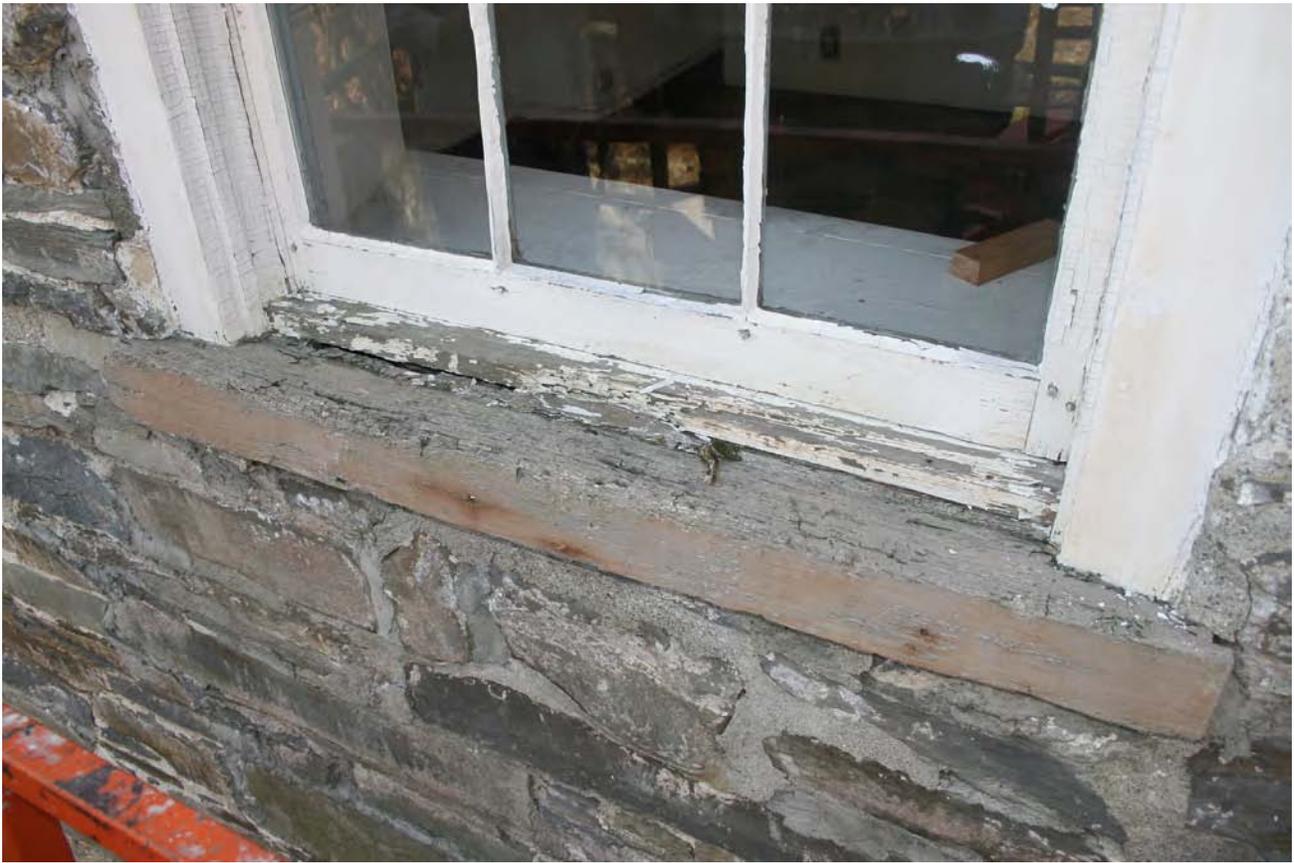
Fig. 42 - Hoffman house. North elevation, second floor. Representative condition of the wood window sills.

The later windows added to the building at the first and second floors maintain the six-over-six light configuration of the earlier sash. At the half-story a number of two-over-two windows were installed replacing the earlier three-light sash located there. These sash are in fair condition, and exhibit the common problems of deferred maintenance commonly found in windows of this type and age; paint failing to bare wood, weathered and checked wood, deteriorated glazing putty, etc.

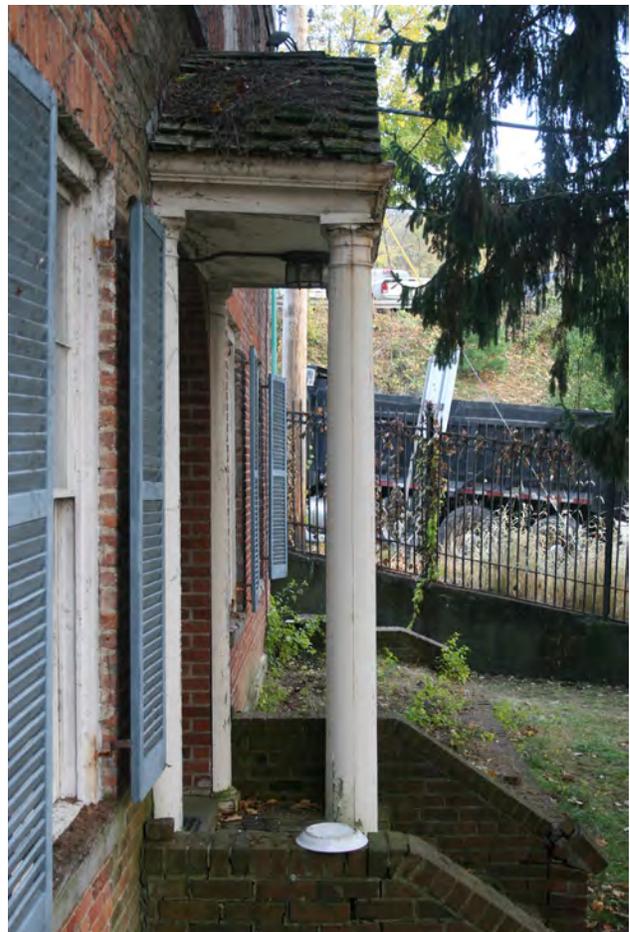
Fig. 45 - Hoffman house. South elevation, west side of portico.

the building. Based on the c.1897 photograph of the building, the appearance of the porch suggests it was constructed as part of the c.1840 improvements to the building (Fig. 46). The porch has a shallow pitched roof with hips at its east and west ends. Pairs of regularly spaced brackets are located across the eaves of the porch. The porch roof is supported by four posts. The posts are finished with cap moldings and bases. The edges of the posts appear to be finished in a manner that creates a panel in the body of the post's shaft. A set of stairs centered in front of the door opening leads up to the porch from grade. The floor of the porch is six or seven risers above grade. Lattice panels fill the space between grade and the porch floor. The two outer bays of the porch have balustrades with turned balusters along their fronts and side.

- *Option One* - Remove portico and planting beds. Stabilize brickwork where planting beds meet steps. Repair brick steps. Clean and repair foundation walls. Reinstate cellar windows at this location.
- *Option Two* - Reconstruct porch as part of a larger comprehensive exterior restoration of the building. Design, construction, and materials should be based on archival information and

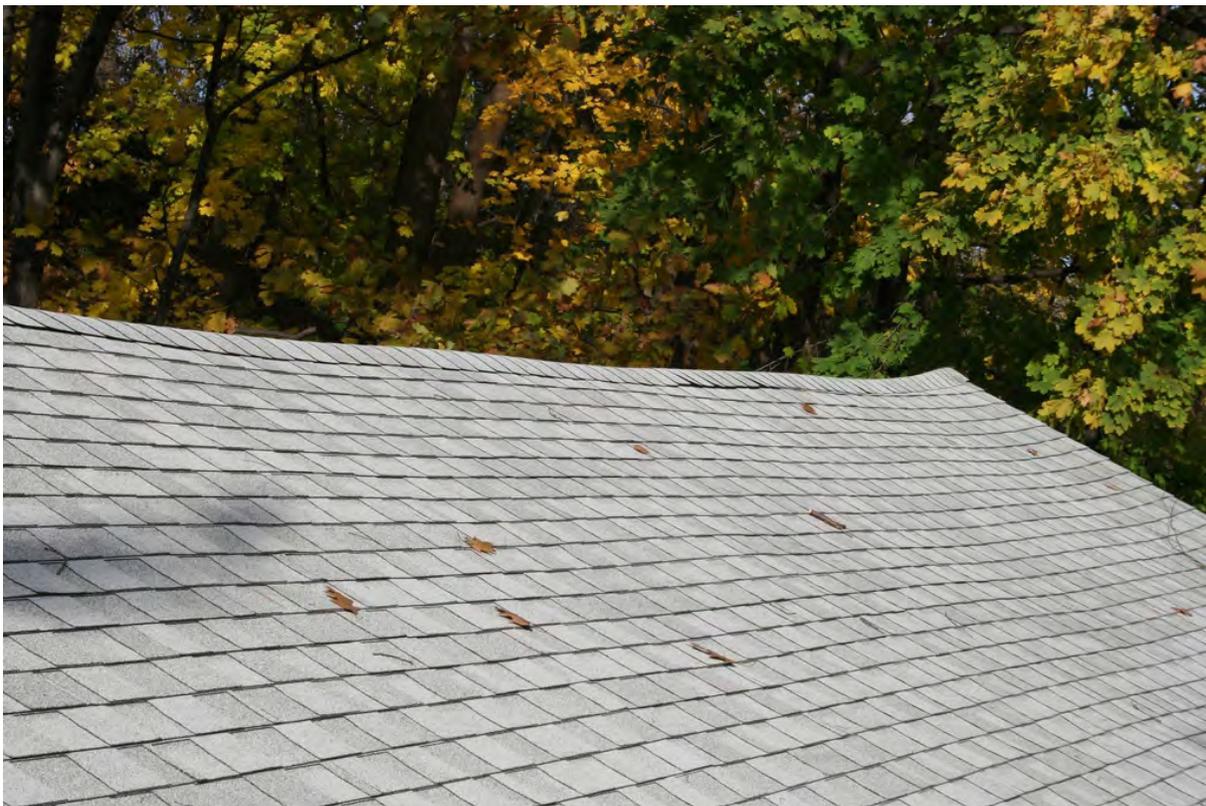
Fig. 57 - Reynolds house. Roof, view looking north. The roofing is in good condition. Note how the roof dips near the far gable.

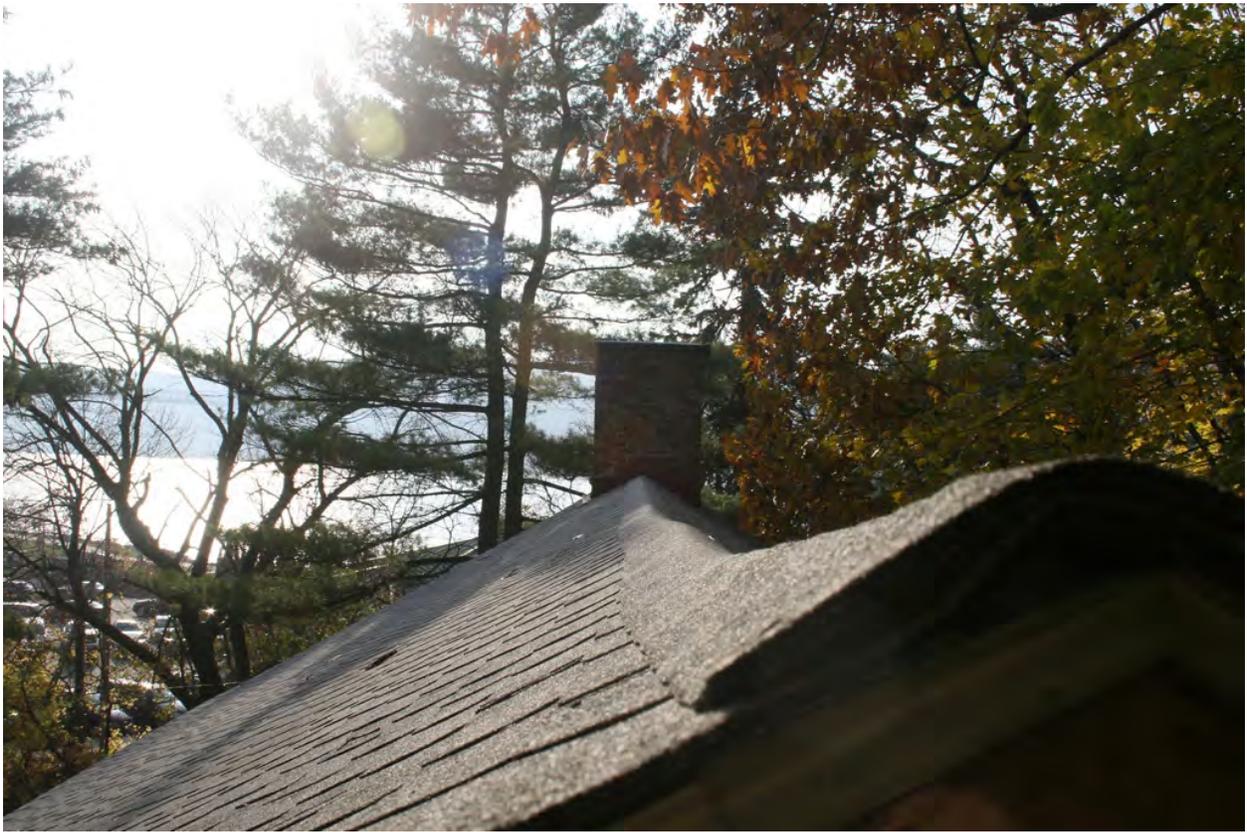
Fig. 58 - Reynolds house. View looking south. Note the saddle in the ridge of the roof.

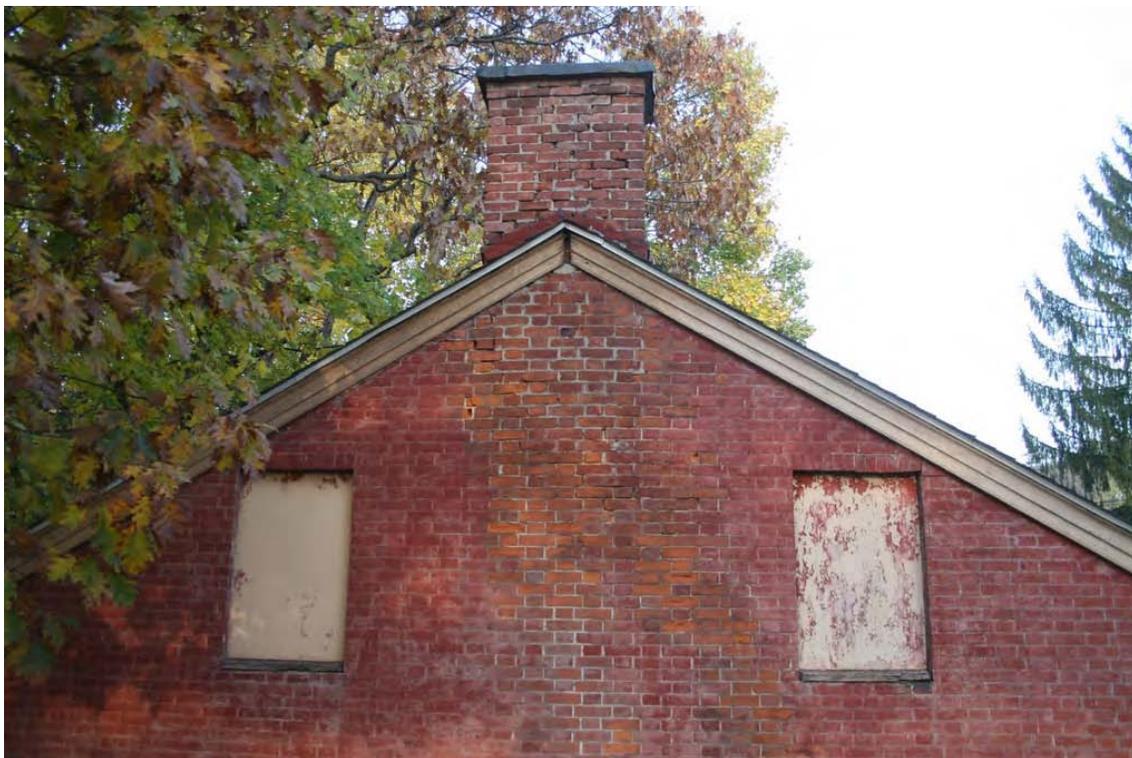
Fig. 59 - Reynolds house. South elevation. The brick along the path of the chimney flue is deteriorated and needs pointing and selective rebuilding.

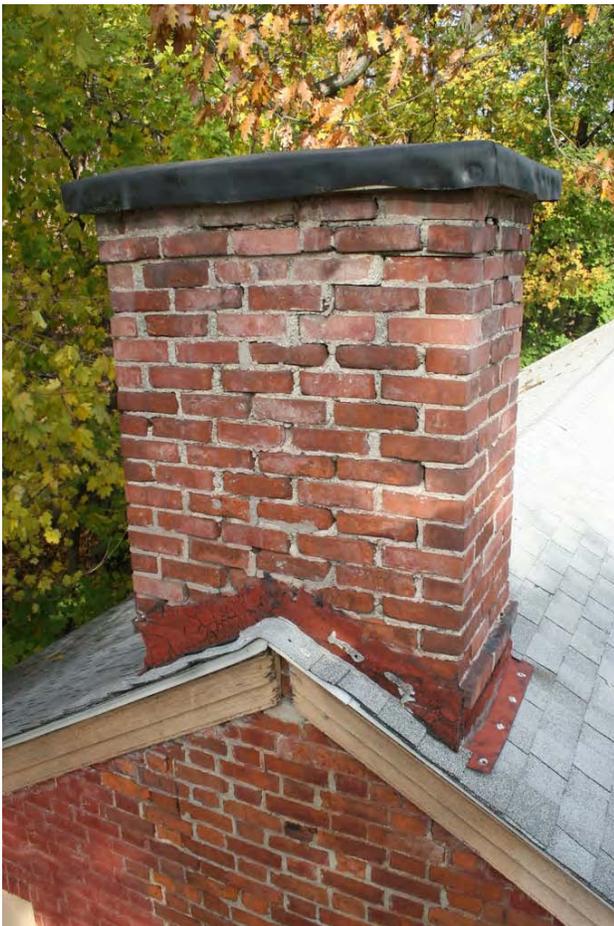
Fig. 60 - Reynolds house. South chimney of main roof. This chimney as well as the end wall below need rebuilding. Note deteriorated condition of brick and mortar, flashing and wood trim.

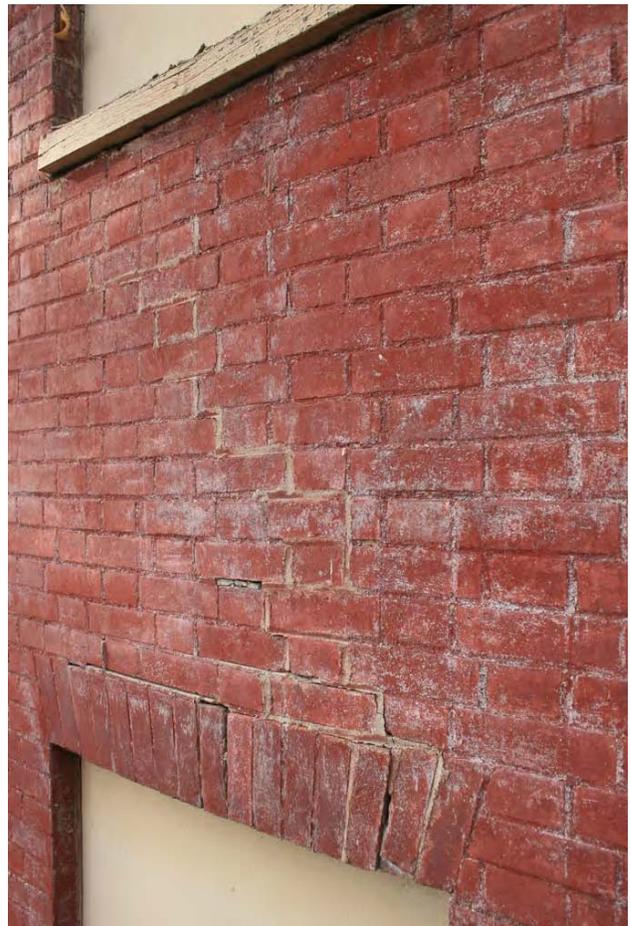
Fig. 61 - Reynolds house. East elevation, between second and third floors. Representative condition of the brick surfaces. Wood sill at top of photograph deteriorated and at the bottom of the image is a failed lintel.

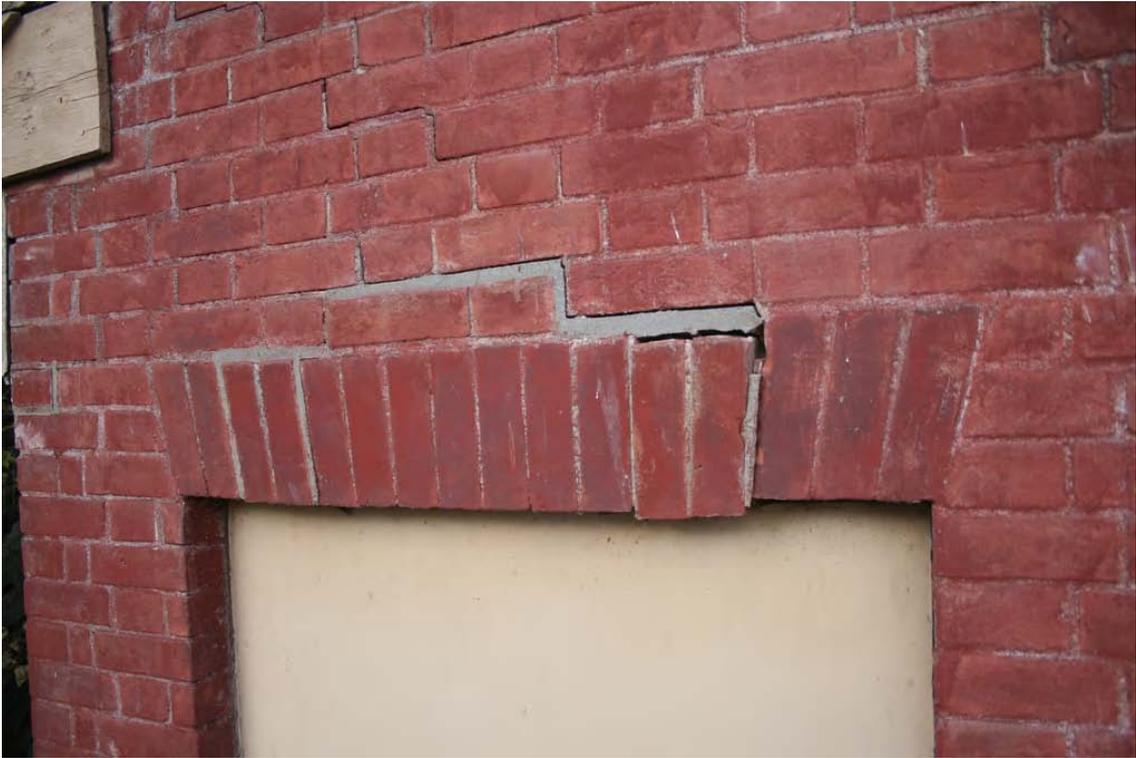
Fig. 62 - Reynolds house. South wing, south elevation. Failed lintel. Past efforts to point the joints display the tell-tale signs of Portland cement mortar. Open gaps indicate the lintel has moved since these repairs were carried out.

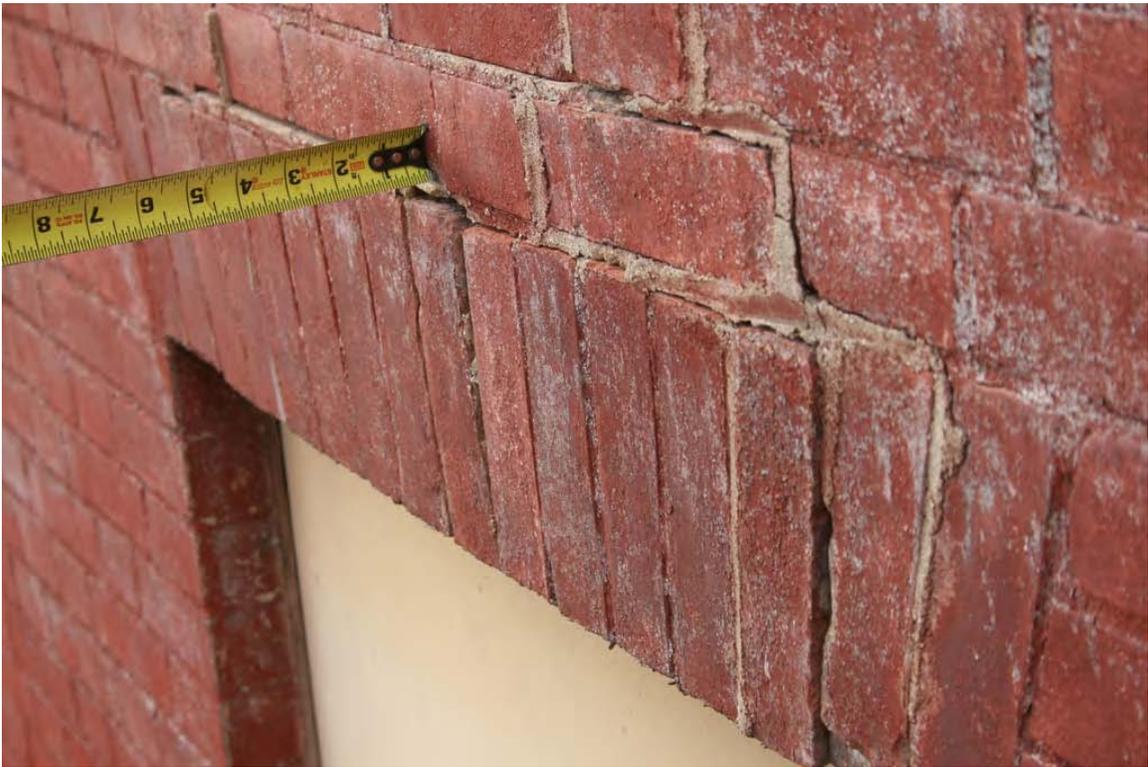
Fig. 63 - Reynolds house. East elevation, second floor. Detail of failing lintel. Bricks has dropped and shifted resulting in open joints.

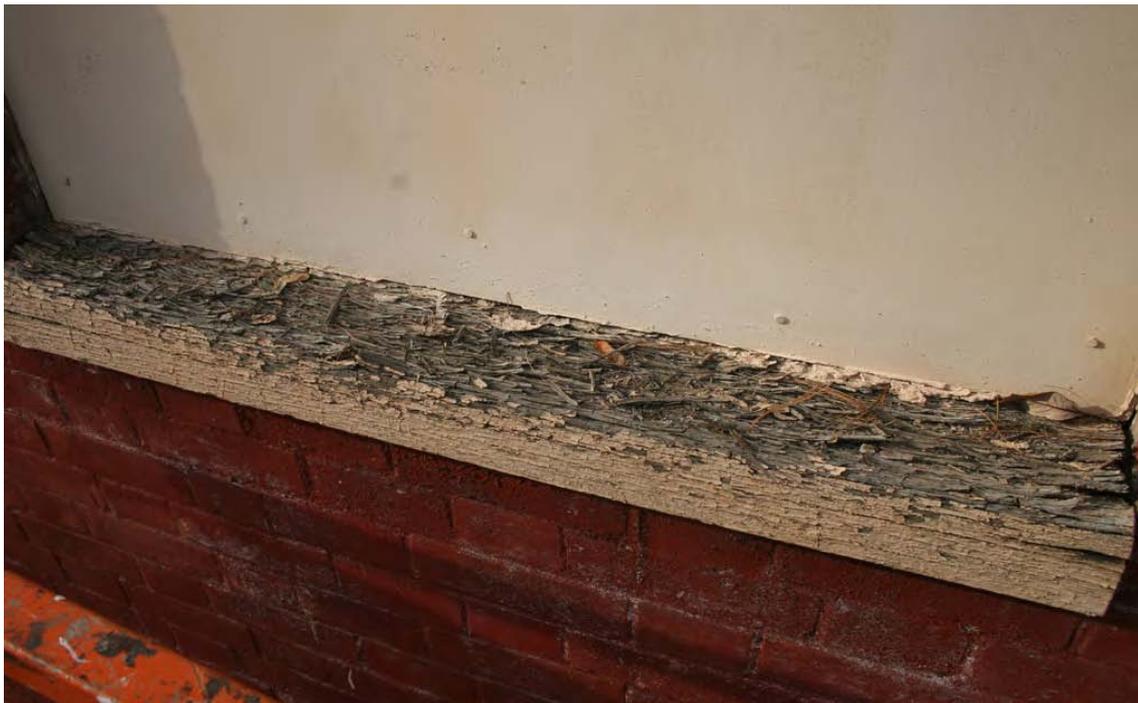
Fig. 66 - Reynolds house. Representative example of the deteriorated condition of the wood window sills.
