The Hoffman and Reynolds Houses

Historic Structure Report

PREPARED FOR
THE DYSON FOUNDATION
MILLBROOK, NEW YORK

FEBRUARY 2013

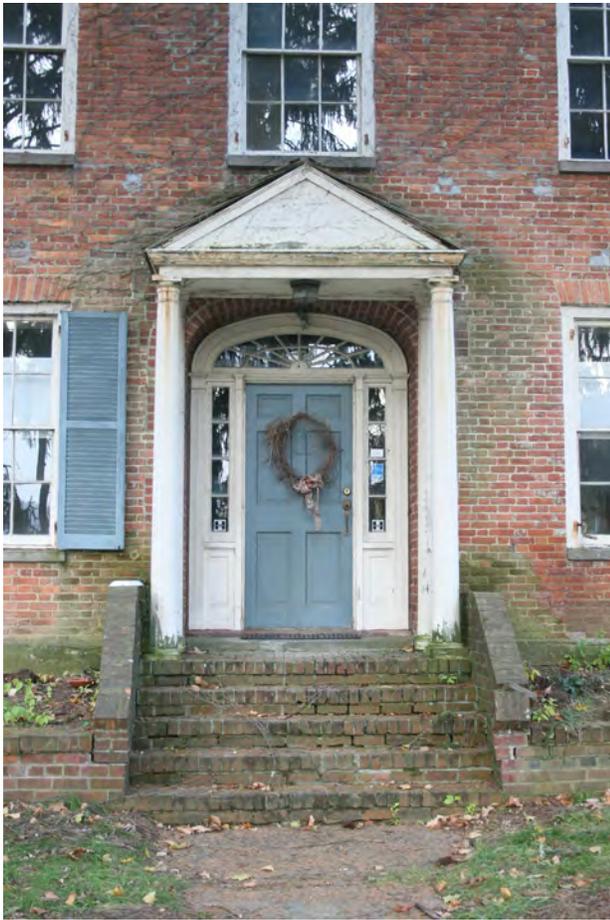
is treated with a Colonial Revival frontis in a pseudo-Federal style. A wood frame “Colonial” style portico shelters the entry and covers the top landing of the steps. These features were all added as part of the c.1920 improvements to the building. The opening for the entry is built using a different type of brick than that used in the façade of the building. The brick used here is a much more uniform, red brick set in Portland cement based mortar. The correlation of this brick type with the c.1920 alterations provides a means of understanding additional changes made to the building at this time (discussed below.)

Fig. 18 - Detail of the Colonial Revival entry and portico. The masonry opening was altered in the early twentieth to accommodate the Federal style door surround. The portico is believed to be contemporary with the door opening or added shortly after.

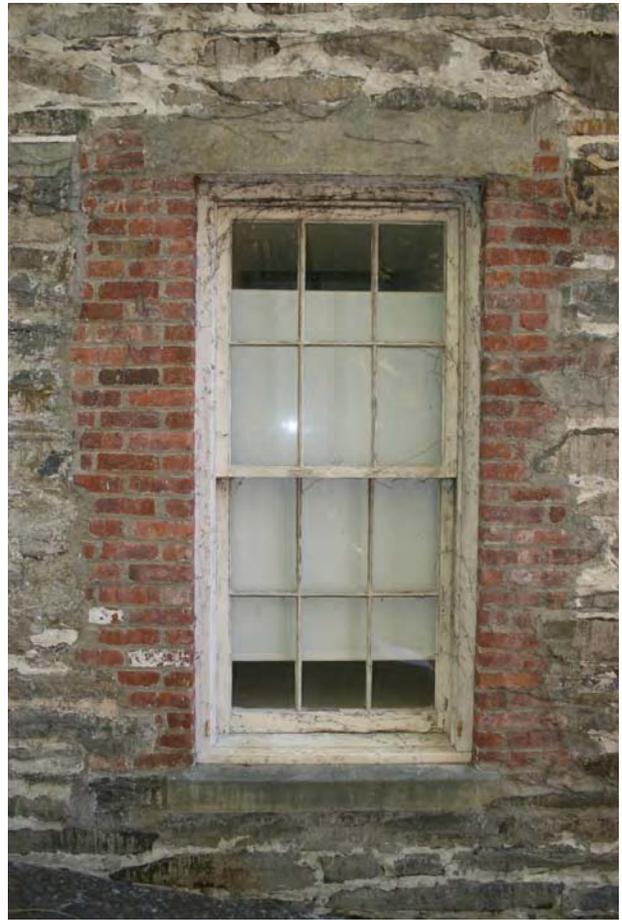
Fig. 19 - Hoffman house, west elevation. Typical example of a later window opening introduced in the stone masonry. This alteration was performed in the Twentieth century. The sides of the opening are built in brick set in Portland cement mortar and the lintels and sills are formed in concrete. Note the dimensions of the sash compared to those found on the south elevation (preceding image).

The second generation of window openings are differentiated by the use of salmon colored brick for the jambs with stone lintels and sills (Fig. 19). These are located at the north end of the west elevation and includes the infilled opening set between floor levels (originally lighting a stairway) and on the east elevation at the south end of the second floor. The opening on the east elevation employs Portland brownstone for the lintel and sill, where on the west elevation lesser quality bluestone/limestone is used. The use of brownstone on the east elevation may have to do with it facing the street, making it a more public façade versus the west elevation that is hidden

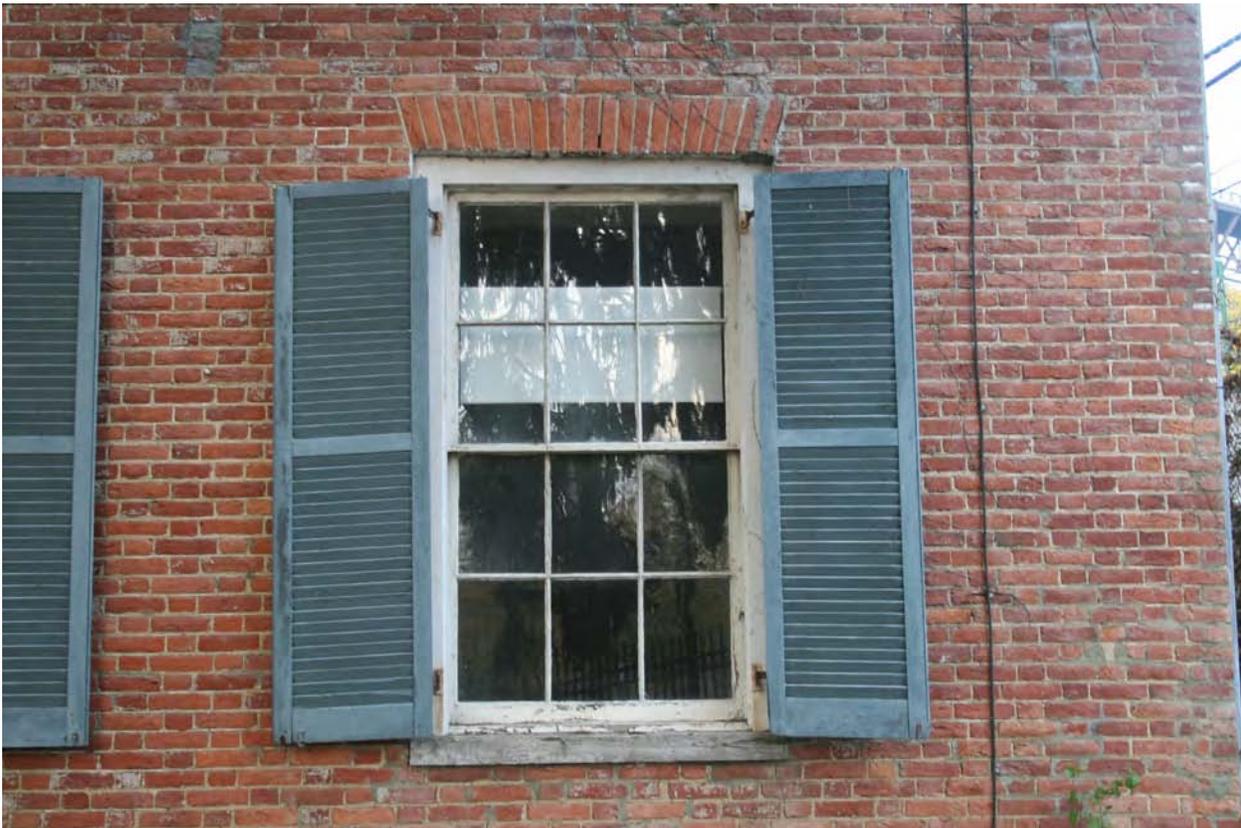
The window openings in the masonry on the south (front) and north elevations are in their original locations and, with the exception of the door opening introduced at the second floor on the north side of the building, do not appear to have been altered (Fig. 20). The shutters and their respective hardware are later additions and date to the c.1920 renovation of the building.

Fig. 20 - Hoffman house, south elevation. Representative example of wood sash and frames, shutters, and brick opening.

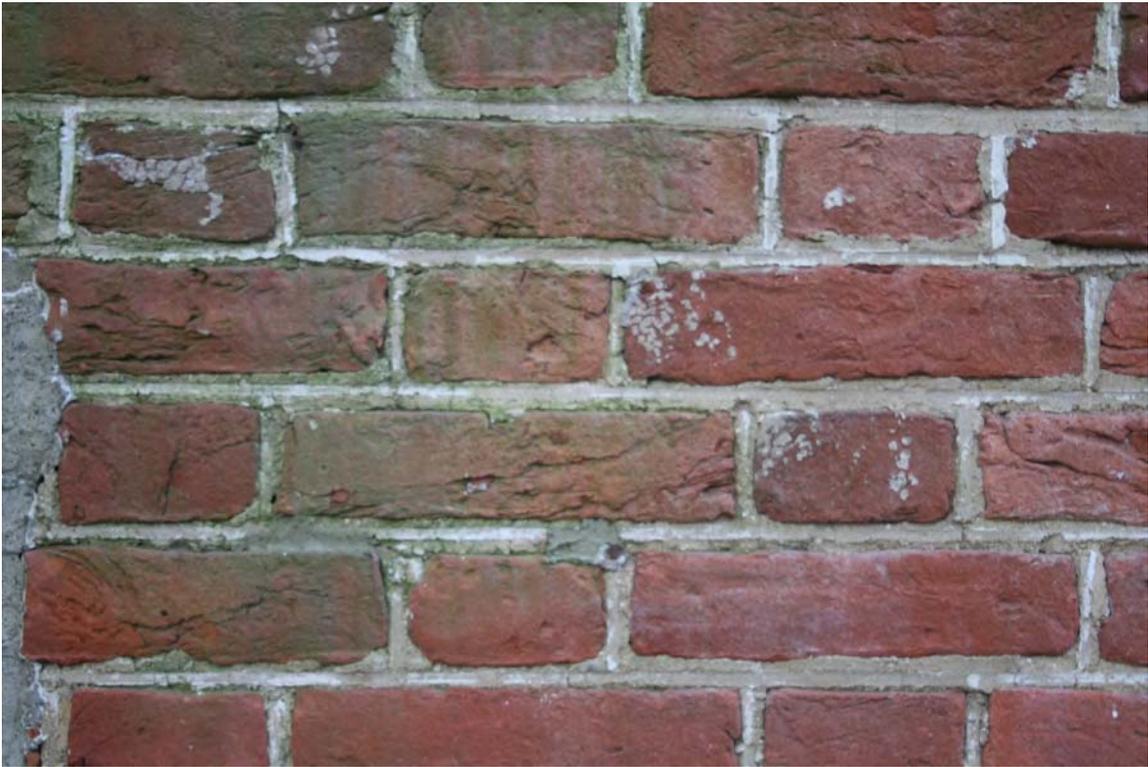
The brick on the south elevation is laid in Flemish bond, a method of setting each course of the brick in alternating headers and stretchers, with each header centered above and below a stretcher (Figs. 20+21). Surprisingly, a high percentage of early, likely original, mortar remains on this elevation. The bricks are set in ruled joints that have been penciled, that is to say that after the mortar joint had been struck with a trowel, it was tooled again with a joint rule run along a straight edge resulting in a uniform narrow bead being pressed into the mortar joint. This incised bead was then painted white to enhance the appearance of the brickwork. Ground floor areas that were sheltered by a porch that once ran across the front of the building and locations behind the shutters still retain good examples of penciling.

Fig. 21 - Hoffman house, south elevation. Brick laid in Flemish bond. Note the ruled and penciled mortar joints.

As noted in the exterior description, the original bricks are set in ruled joints that have been penciled, that is to say that after the mortar joint had been struck with a trowel, it was tooled again with a joint rule run along a straight edge resulting in a uniform narrow bead being pressed into the mortar joint (Fig. 21). This incised bead was then painted out white enhancing the appearance of the brickwork.

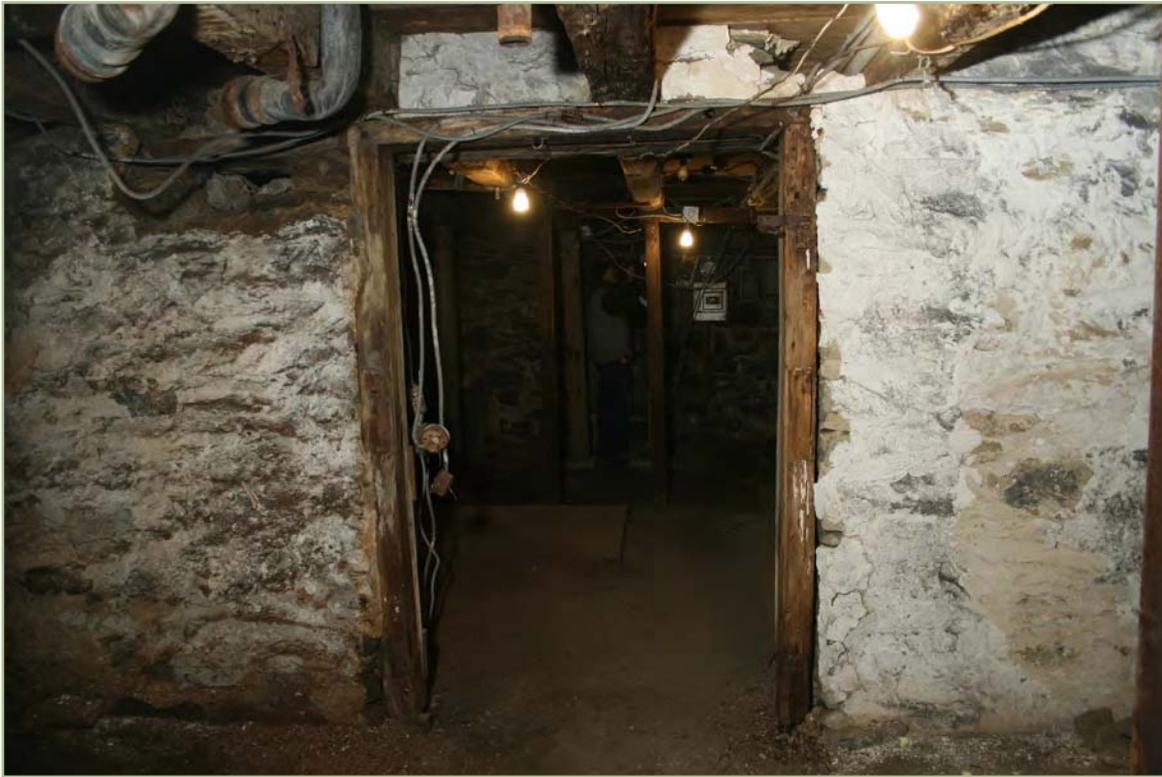
principal areas divided by the east-west wall that runs across the middle of the cellar. Initially, the only door allowing access between these two spaces is that found on the east side of the cellar containing an early, probably original, joined door jamb in its opening (Figs. 24+25). The opening in the masonry in the center of the cellar is a later introduction, as evidenced by the rough jambs where the stone has been removed. Just north of this opening an earlier, likely original, set of stairs lead from the first floor down into the cellar. This accounts for the jog in the stone wall here which provides the necessary room for circulation around the stairs and access to the eastern part of the cellar. The brick wall along the west side of this stair bears the impression of the stair stringer as it passed down from the first floor to the cellar. This suggests the wall was added at a later date and was built to accommodate the existing stair.

Fig. 24 - Hoffman house, cellar. View looking south. Early door opening between east rooms.

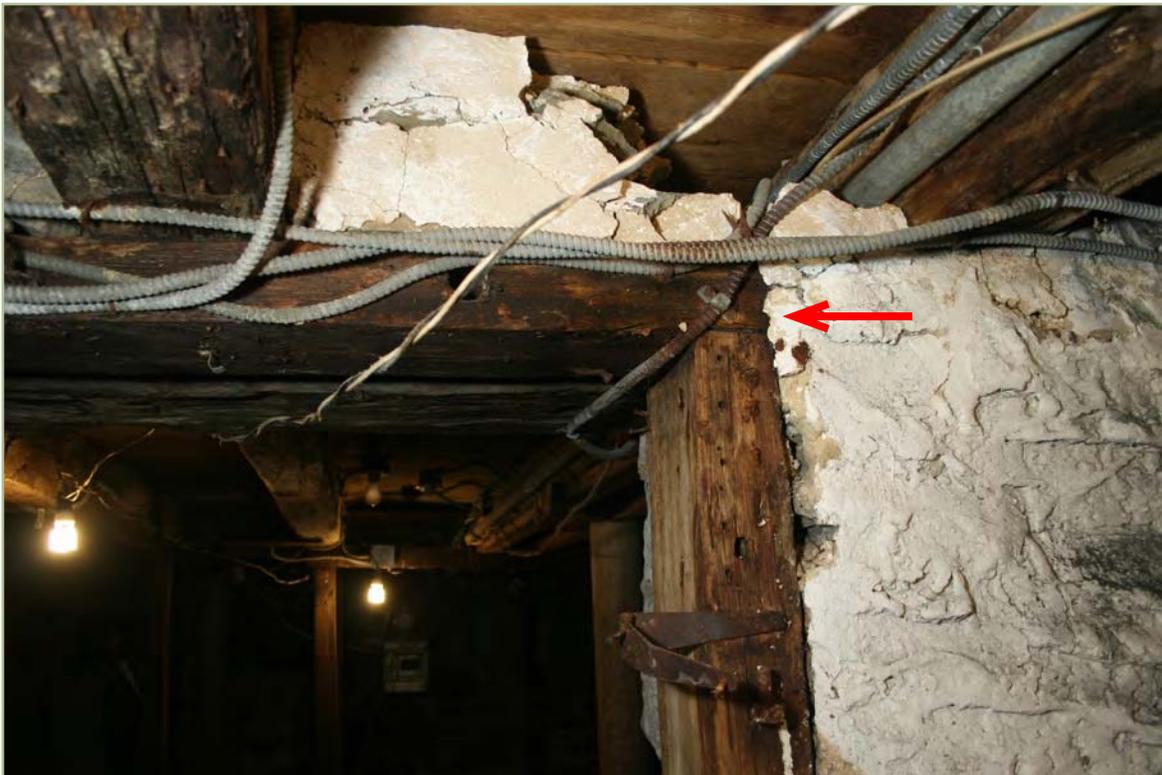
Fig. 25 - Hoffman house, cellar. View looking south. Detail of door frame illustrated in preceding image. Arrow identifies location of joinery used to construct this element.

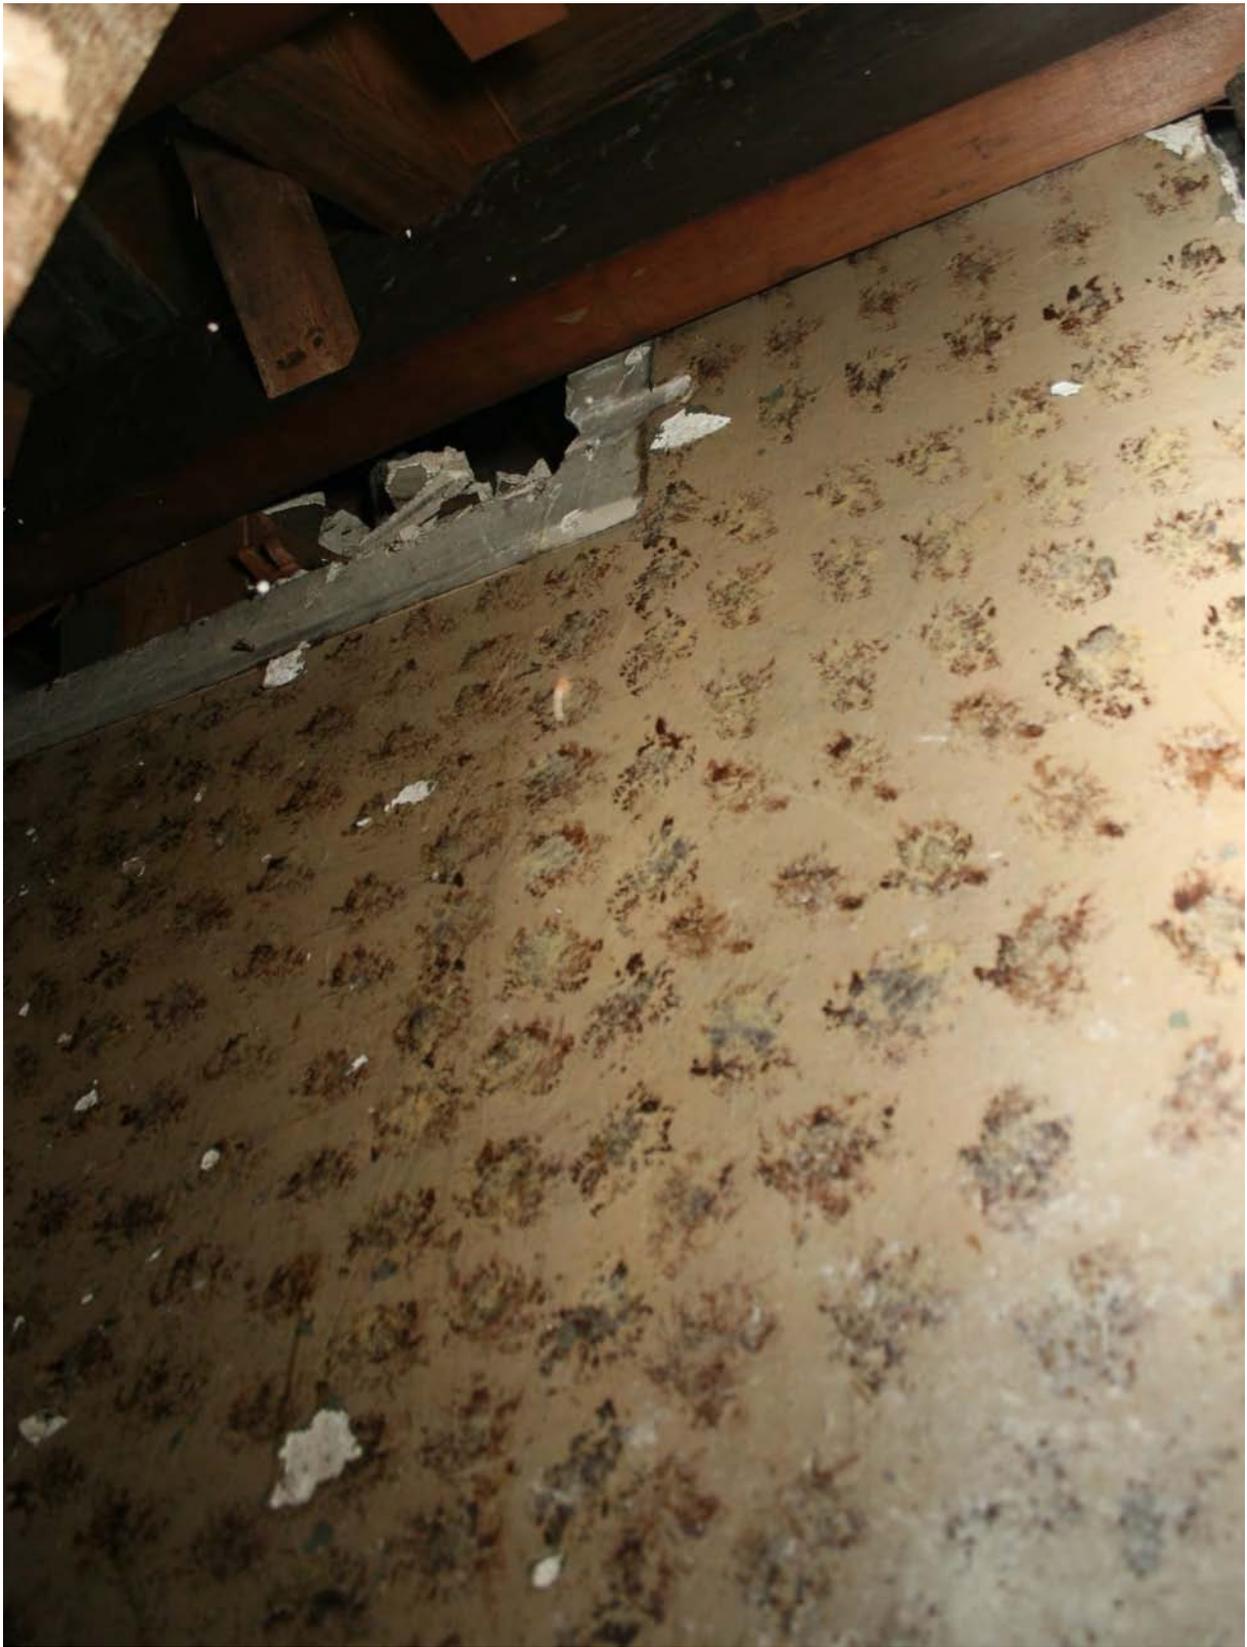
- Portions of a plaster wall remain insitu on the west wall here (Fig. 31). Owing to the window opening located between floor levels, this space is believed to be part of a c.1840 stair that ran between the first and second floors. The plaster is applied to circular sawn wood lath applied

Fig. 31 - Hoffman house. First floor middle room. A large portion of the earlier plaster wall remains buried behind the existing west wall of the room. The unpainted plaster at the top of the image is where a window architrave and apron was located. The wall is painted with an early rag or sponge applied finish.

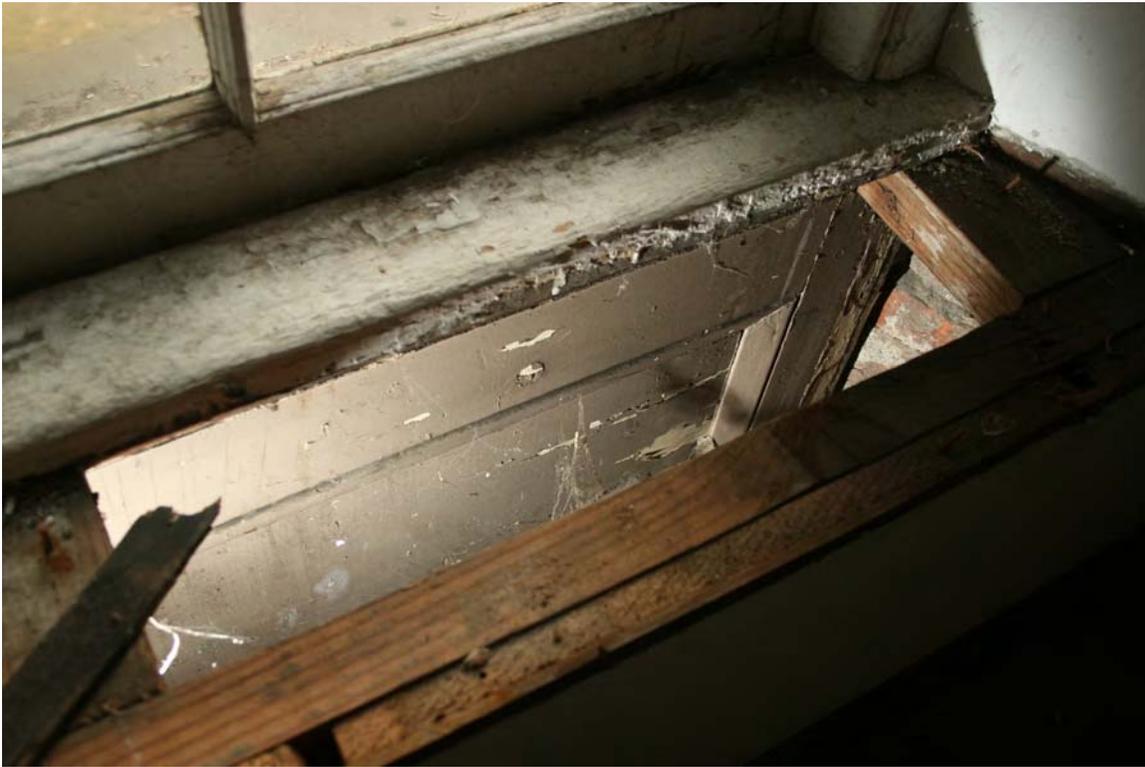
Fig. 32 - Hoffman house, second floor, southeast room. Recessed panel with flattened quirked ovolo located under east window opening.

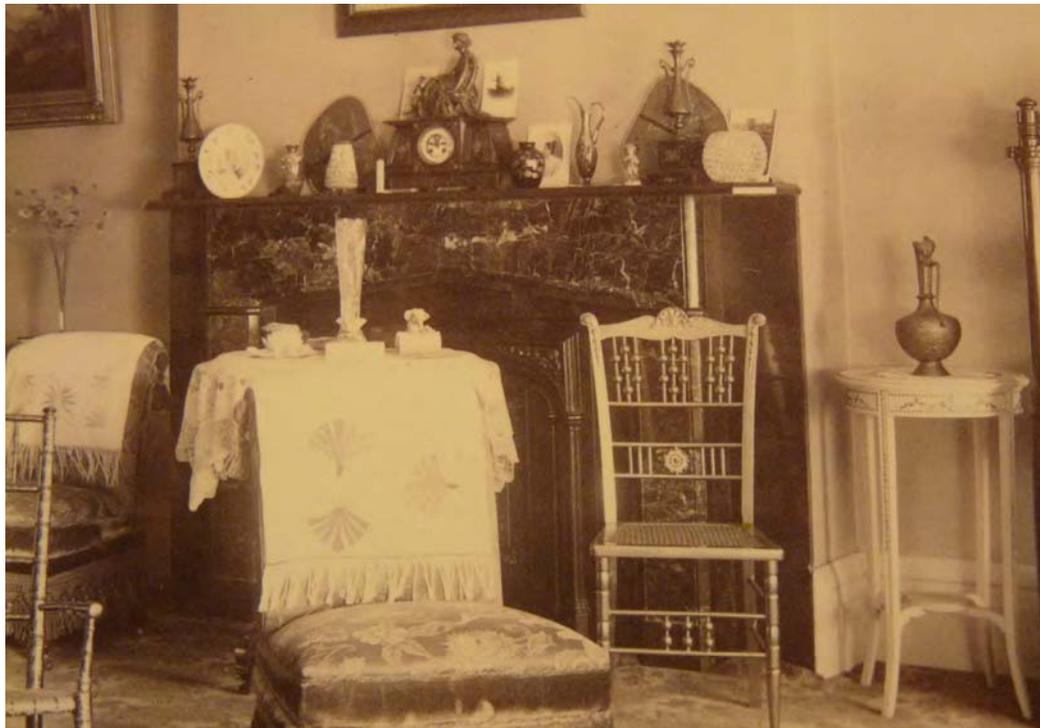
Fig. 35 - Hoffman house. Detail of parlor photograph showing the black mantel in-situ. Photo dated January 19th, 1897. Courtesy of Locust Grove Historic Estate archives.

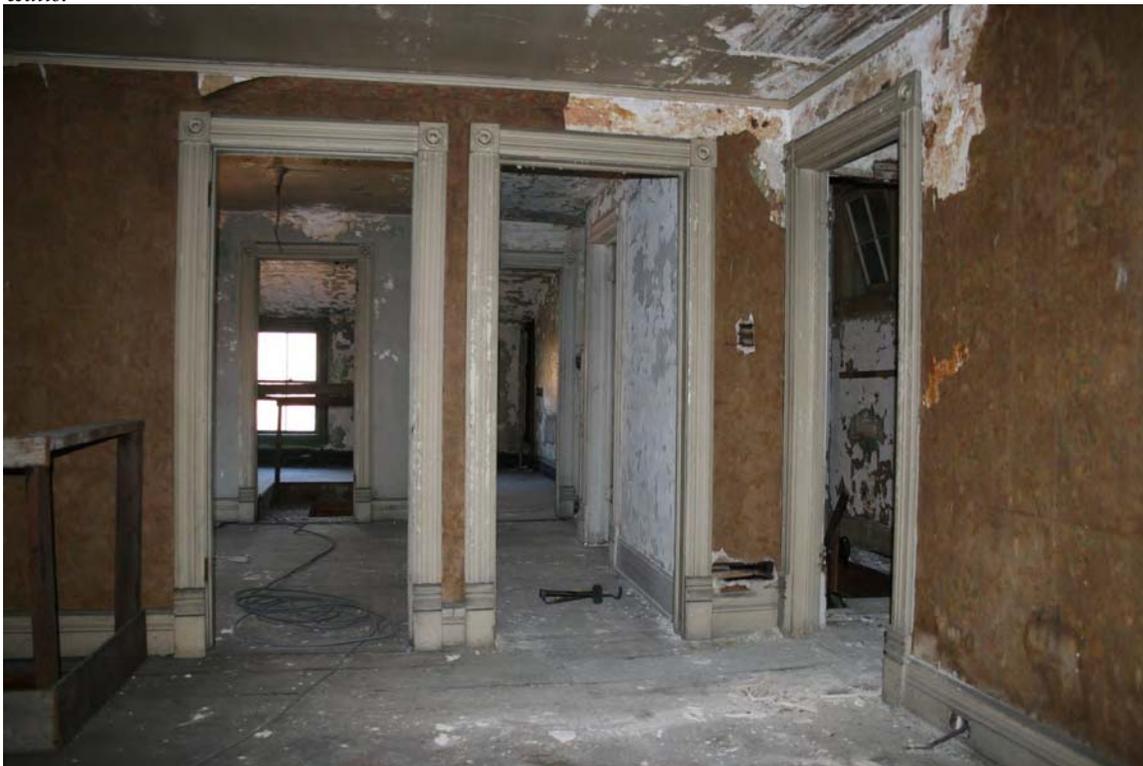
- The majority of the remaining finishes -- plaster, wallpaper, trim -- date to c.1900. The door and window architraves, baseboards, and crown molding is all composed of machine run mill-work typical of the period (Fig. 38). The portions of the chimney stacks which run through this space are plastered and in some cases finished with the same wall paper used in the

Fig. 38 - Hoffman house. Half-story, southwest room. View looking north. All of the woodwork -- door architraves, corner blocks, base boards -- at this level is late-nineteenth, machine run millwork.

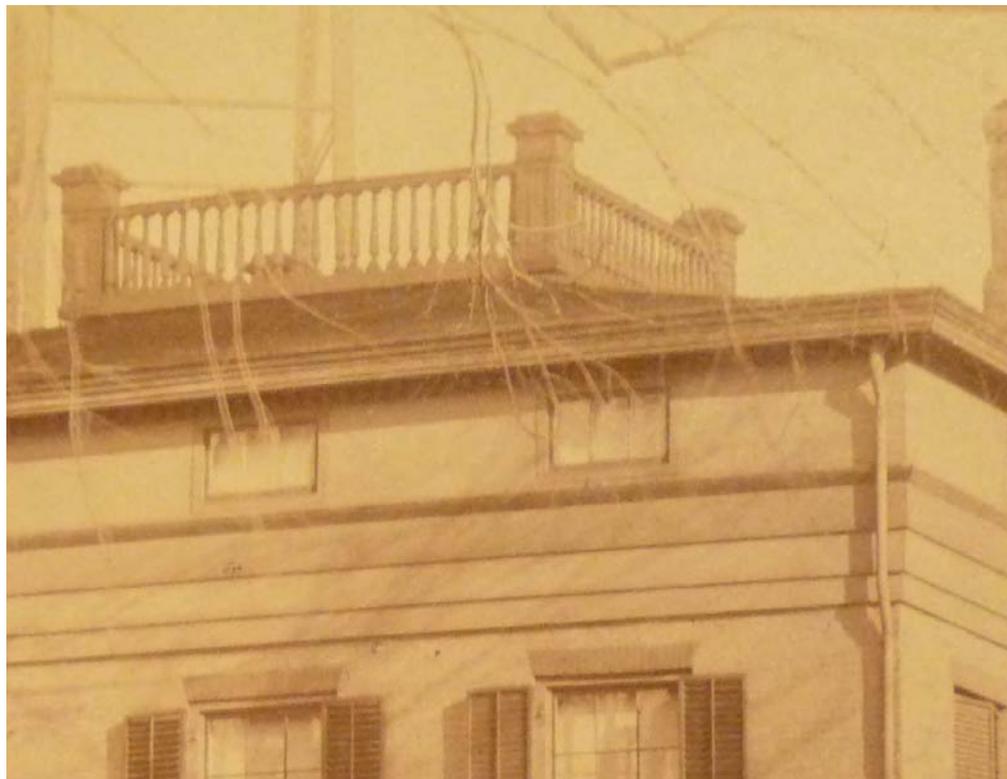
Fig. 41 - Hoffman house. Detail of late-nineteenth century photograph showing roof balustrade. Note the turned balusters. Also notice the design and configuration of the cornice. The leader pipe at the right of the image exists from under the cornice, suggesting a built-in gutter. Courtesy of Locust Grove Historic Estate archives.

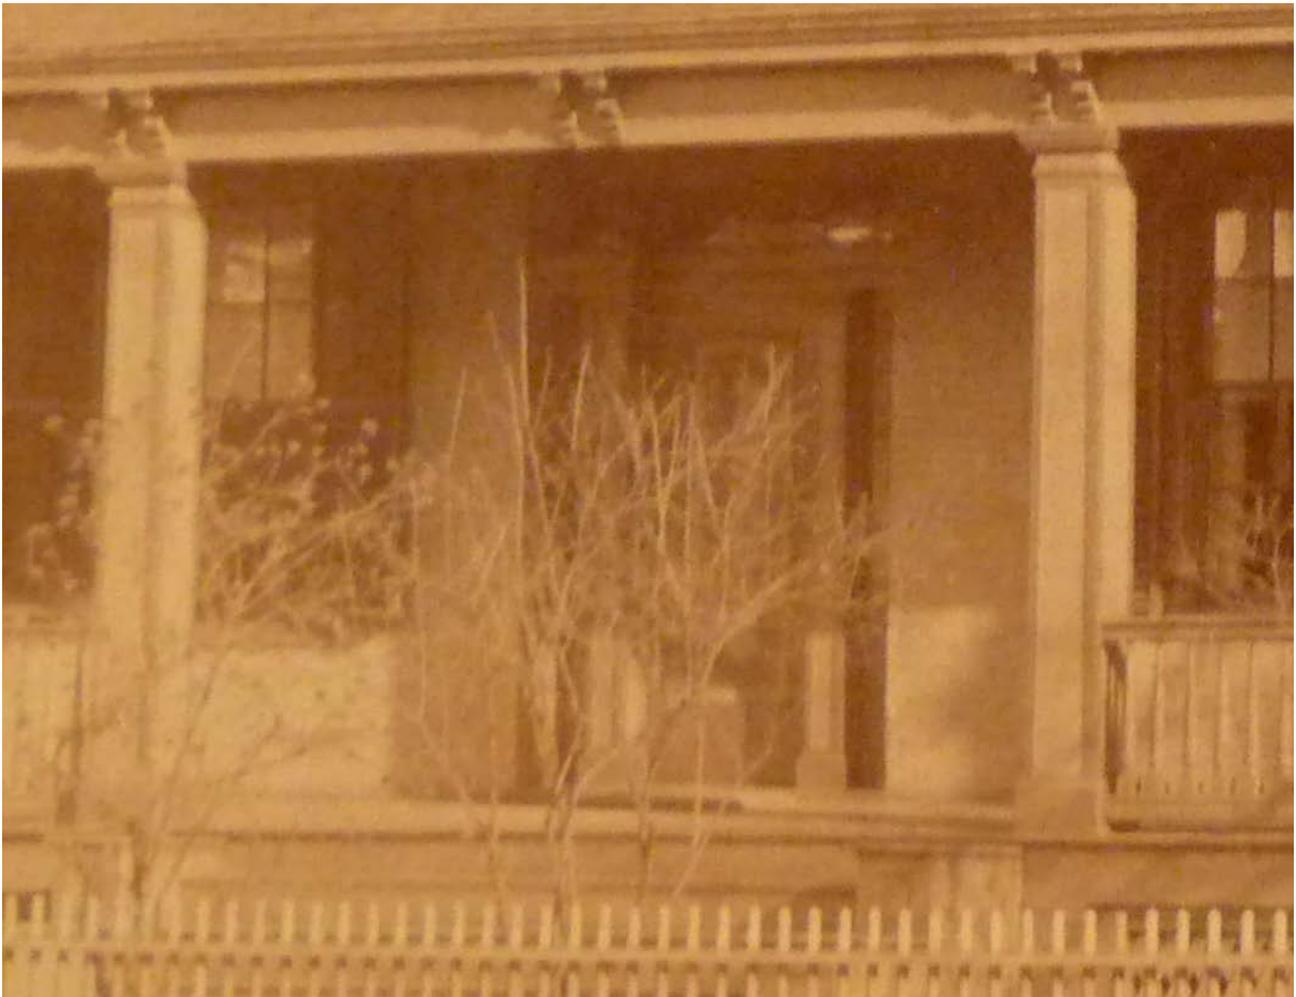
Fig. 43 - Hoffman house. Detail of south door opening. Photograph dated January 19th, 1897. Courtesy of Locust Grove Historic Estate archives.

- Front (south) entry - Reconstruct entry opening, door and surround in a design approximat-

ing its nineteenth century appearance.

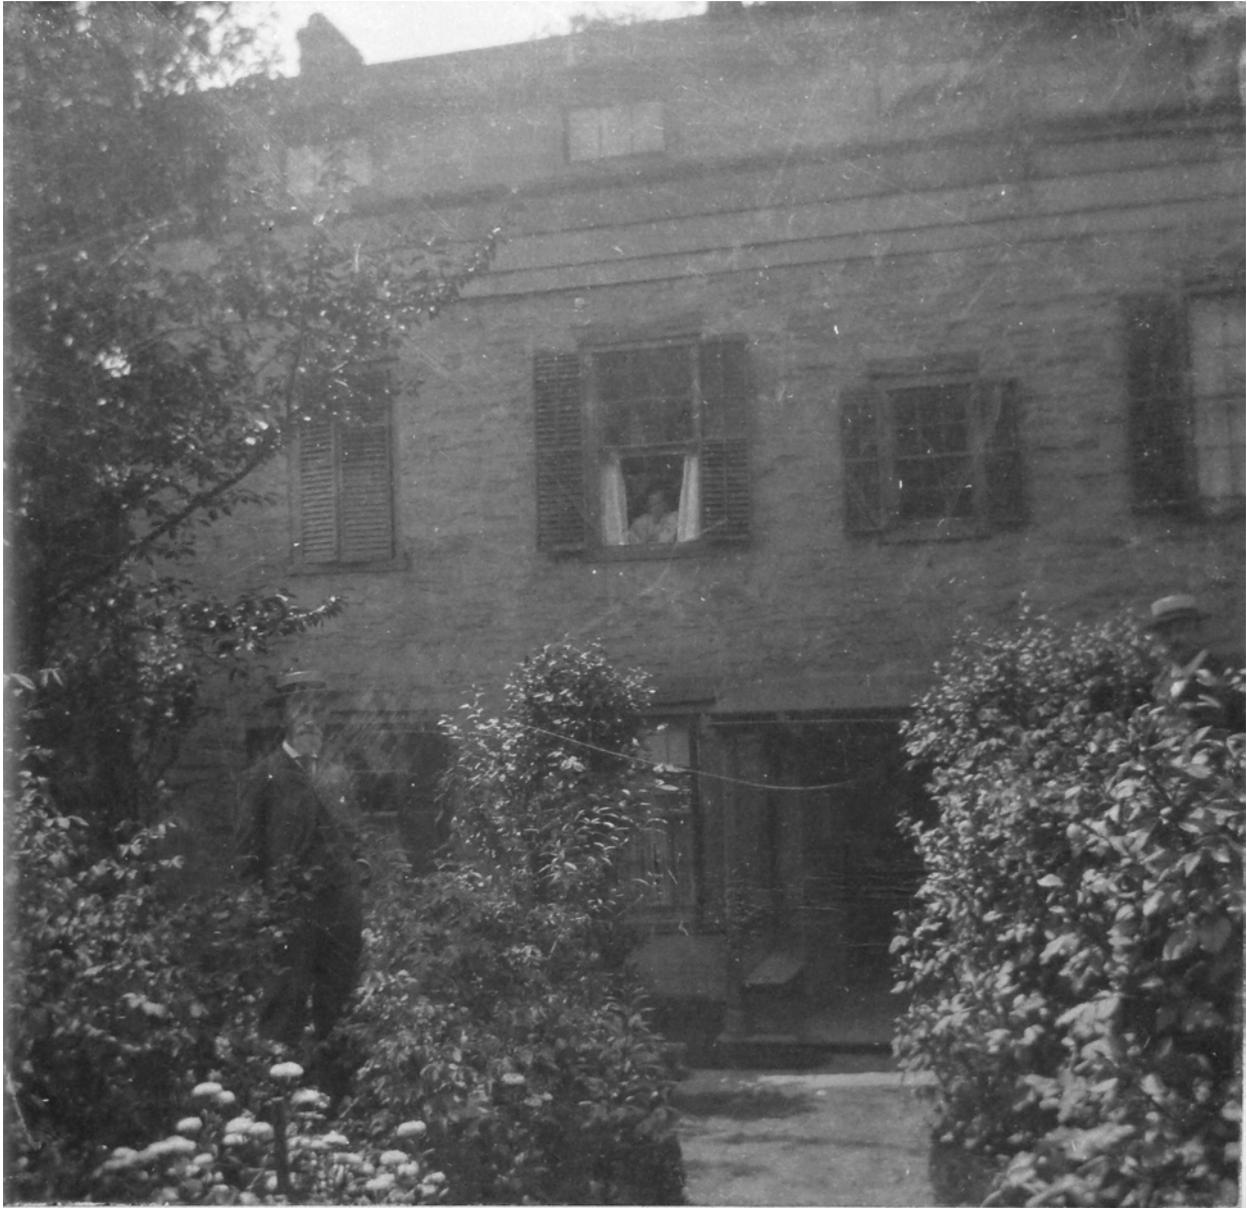
The second floor door opening on the north side of the building was originally a six-over-six sash window. (Fig. 44). This window was slightly smaller than the adjacent windows on account that it was located within the stairway landing between the first and second floor.

the building are twentieth century elements. The masonry opening at the first floor is original. By the late-nineteenth century this opening lead out to a small covered stoop with benches in a fashion typical of the region (Fig. 44).

Fig. 44 - Hoffman house. Detail of photograph showing north elevation. Not dated. Smaller stair hall window can be seen at the second floor. Note the covered stoop at the door opening. Also notice the location and design of the windows in the half story. Courtesy of Locust Grove Historic Estate archives.

- Back (north) entry - As this elevation is not as visible as the south elevation, repair of this entry does not need to follow historic precedent. The existing woodwork finishing the opening should be retained, repaired and painted. A new door should be installed to secure this opening.
- Second floor north entry - The need and functionality of access and a door at the second floor level may be dependent on the final use and program of the building. If not necessary, this door opening should be returned to a window opening based on the size, scale, and configuration of what once existed at this location.

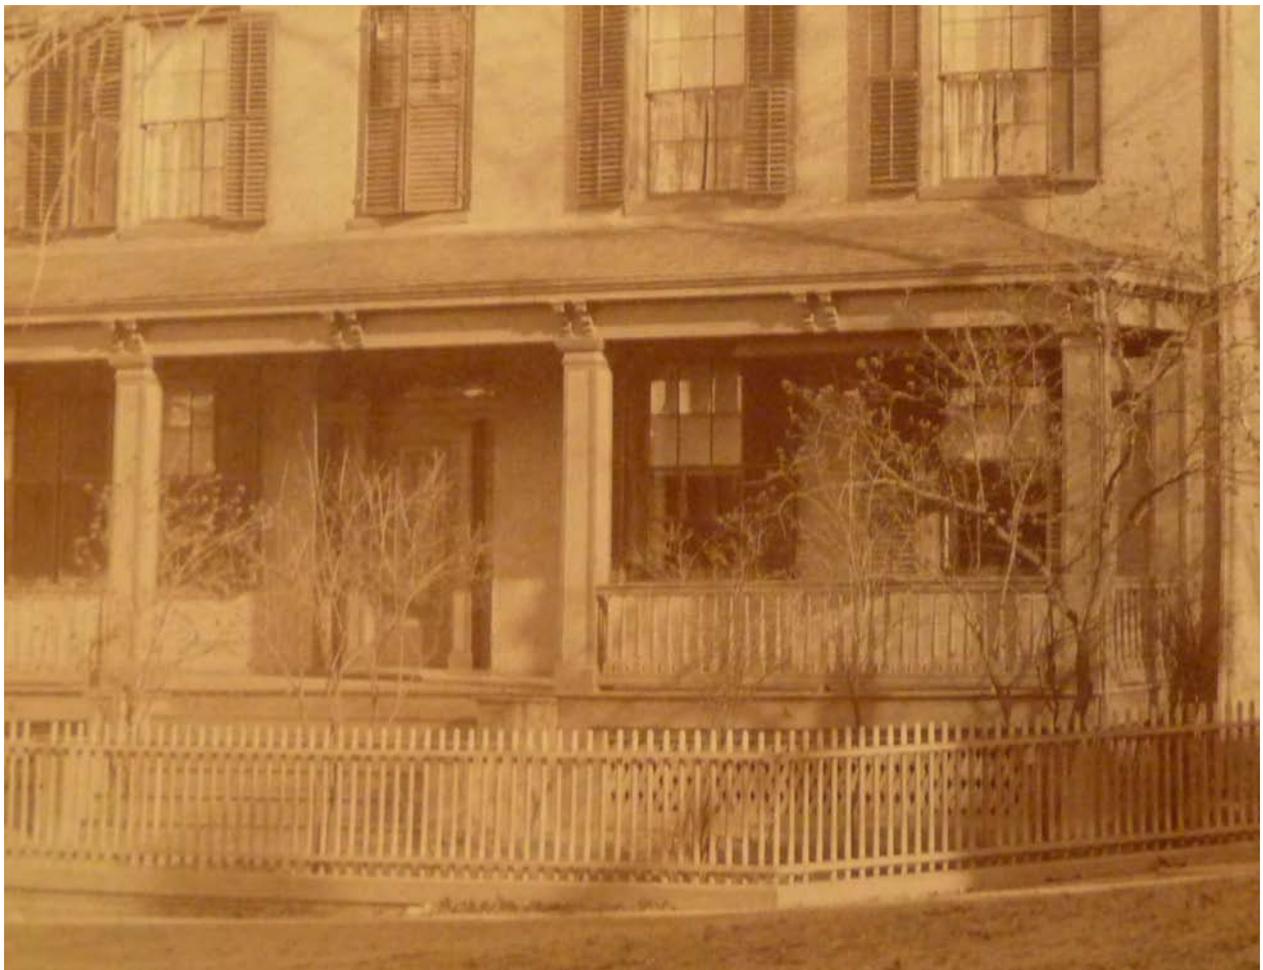
the building. Based on the c.1897 photograph of the building, the appearance of the porch suggests it was constructed as part of the c.1840 improvements to the building (Fig. 46). The porch has a shallow pitched roof with hips at its east and west ends. Pairs of regularly spaced brackets are located across the eaves of the porch. The porch roof is supported by four posts. The posts are finished with cap moldings and bases. The edges of the posts appear to be finished in a manner that creates a panel in the body of the post's shaft. A set of stairs centered in front of the door opening leads up to the porch from grade. The floor of the porch is six or seven risers above grade. Lattice panels fill the space between grade and the porch floor. The two outer bays of the porch have balustrades with turned balusters along their fronts and side.

Fig. 46 - Hoffman house. Detail of photograph showing south elevation. Note the porch elements: paired brackets, paneled posts, turned balusters, lattice, and steps. Courtesy of Locust Grove Historic Estate archives.

Owing to the advanced state of decay the portico, steps, and planters are in their comprehensive repair is not recommended; however, given the need for safe access into the building, a solution for addressing the steps must be considered. Treatment options include:

- *Option One* - Remove portico and planting beds. Stabilize brickwork where planting beds meet steps. Repair brick steps. Clean and repair foundation walls. Reinstate cellar windows at this location.
- *Option Two* - Reconstruct porch as part of a larger comprehensive exterior restoration of the building. Design, construction, and materials should be based on archival information and

period construction methods.

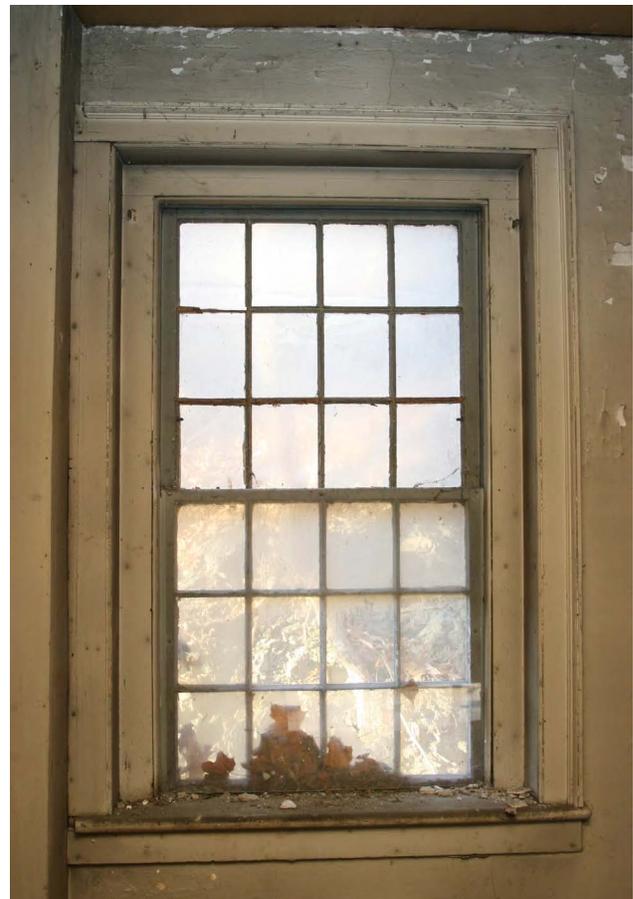
Fig. 47 - Reynolds house. Second floor, west elevation. Representative example of an original, Federal style, single fascia window architrave.

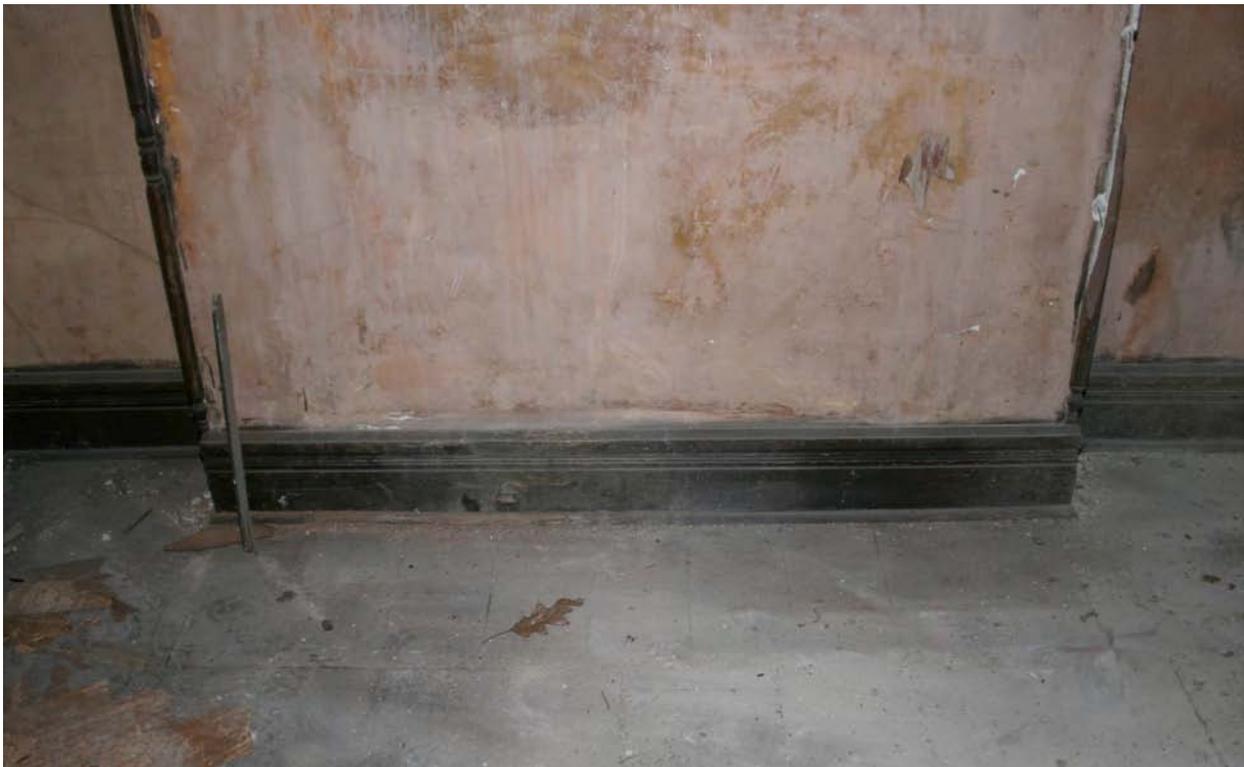
Scars in the flooring indicate that the front (east) rooms originally had fireplaces in the end walls (Fig. 55). Three mantel shelves were found in one of the closets in the building.

Fig. 55 - Reynolds house. Third floor, north elevation. Detail of patch in flooring where the forehearth of the fireplace extended to. Based on the later finishes, it appears this was removed when the building was renovated into a tenement house.

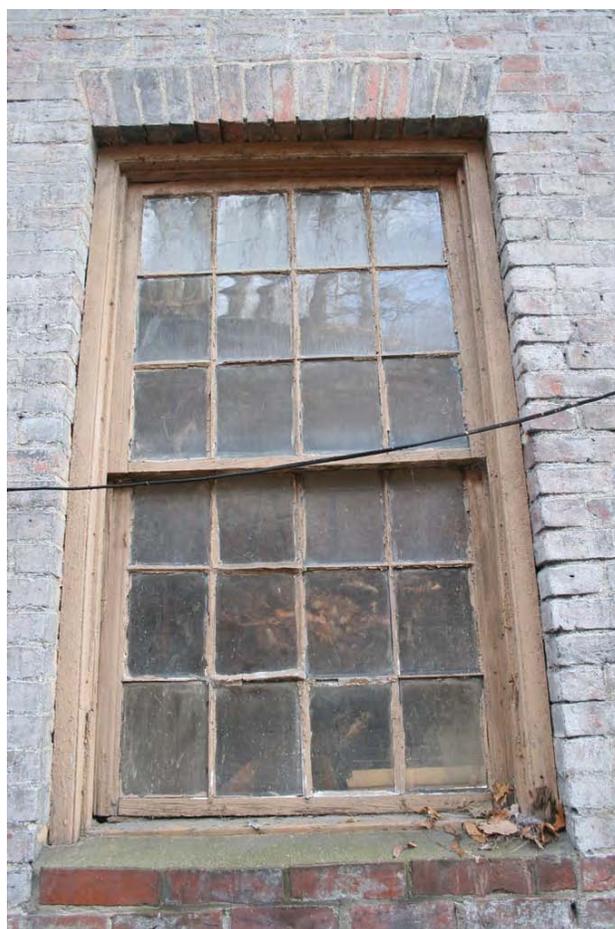
With the exception of three windows on the west side of the building, all of the window sash have been removed or a later replacement. Two of the three remaining sash are early (c.1810) twelve-over-twelve light sash, the third is a later (c.1880) two-over-two light sash. The twelve light sash are unique in that the c.1867 photograph shows six-over-six light sash in the windows. It may be that the six-light sash were added on the visible elevations of the building at a later date and on the less prominent rear of the building the early sash were simply left in place. It is also feasible that the building started life with six-over-six sash on the prominent elevations (east and south) and twelve-over-twelve light sash on less prominent elevations.

Fig. 64 - Reynolds house. West elevation, second floor. One of two remaining twelve-over-twelve light windows.

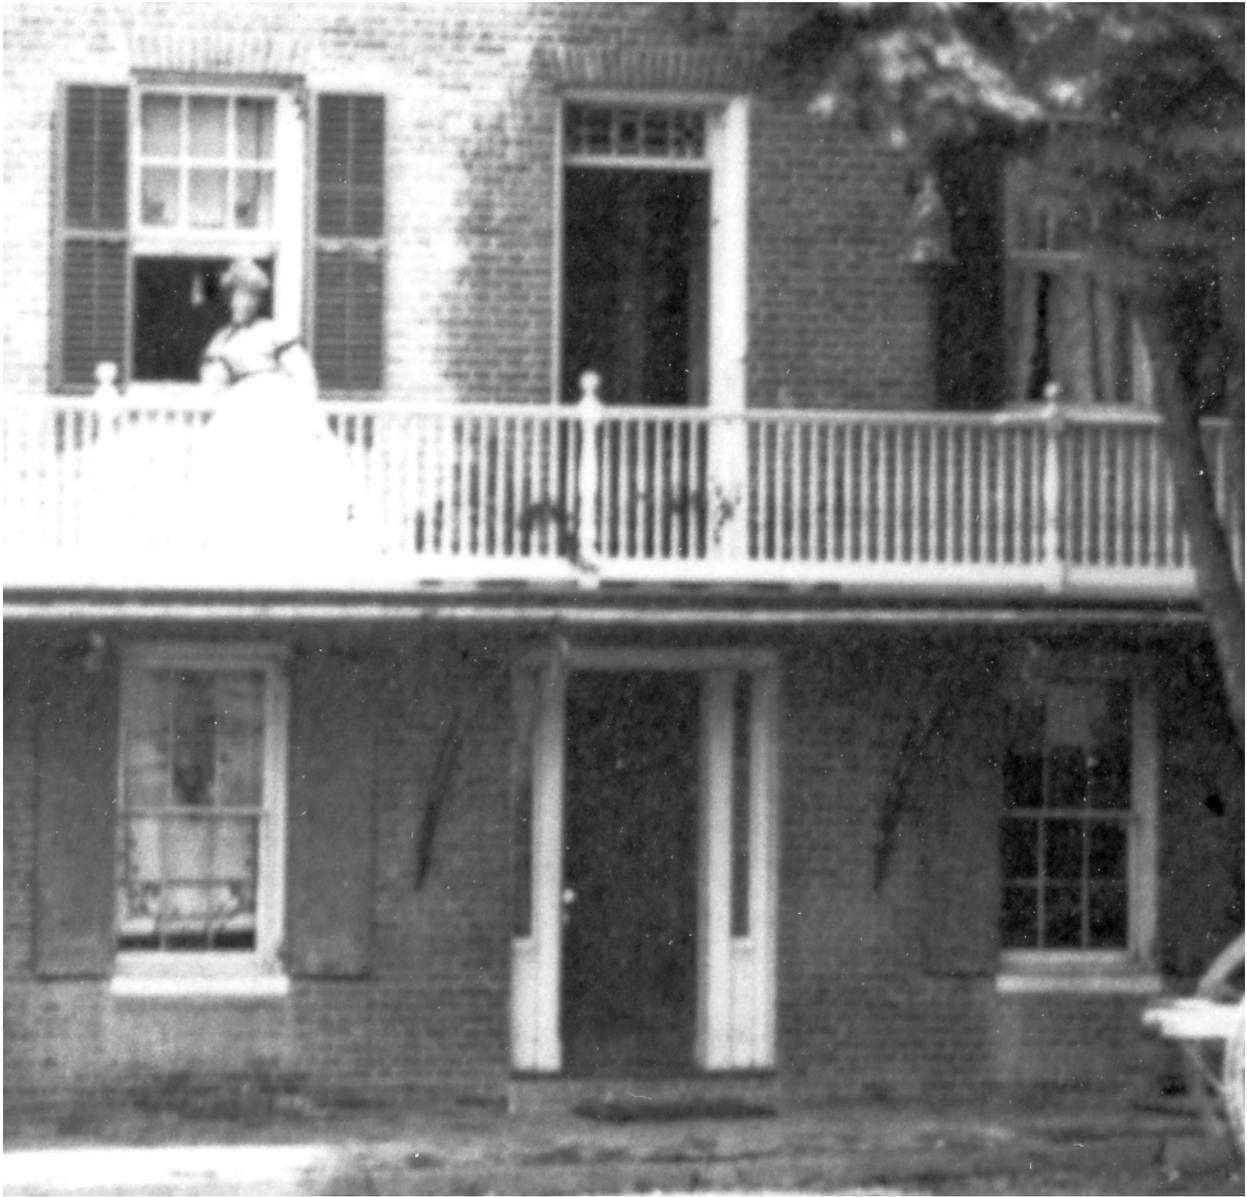
All of the window openings originally had operational shutters on them. The style and design of the shutters at the first floor level was different than the floors above. Unlike the louvered shutters on the upper floors, the shutters on the first floor had what appears to be solid panels (Fig. 67). Stronger shutters may have been used on the ground floor in an effort to secure entry to this floor.

The treatment of the second floor door opening differed from that found on the ground floor. This opening appears to have had a much simpler architrave surround, yet with an elegant transom light above the door (Fig. 67). The delicate design and appearance of the transom suggests the glazing may have been set in ornamented lead cames. The door here would likely have been a wood, stile and rail door with panels.

The second floor porch and the steps leading up to it were both a major architectural feature of the building and a practical necessity (Fig. 67). This feature survived into the twentieth century and shows up in the 1908 photograph of the building. A close examination of the c.1867 photograph reveals the porch was highly ornamental with turned balusters and posts and curved iron brackets supporting it (Fig. 67). Stairs at the north end of the porch ran up towards the building then, turning at a right angle,

Fig. 67 - Reynolds house. Detail of door and window openings. Note the different door frames and treatments. Notice the decorative transom above the second floor door and the differences in first and second floor shutters. Iron brackets support the second floor porch. The balustrade along the porch has turned posts with turned balusters between.

- Any effort to return the exterior of the building to some degree of its earlier appearance needs to take into consideration the restoration of this feature. The porch and steps were a character defining feature of the building and instrumental in experiencing the building and site.
- Reconstruct porch as part of a larger comprehensive exterior restoration of the building. Design, construction, and materials should be based on archival information and period construction methods.
